BREESE STEVENS FIELD

HISTORIC STRUCTURE REPORT

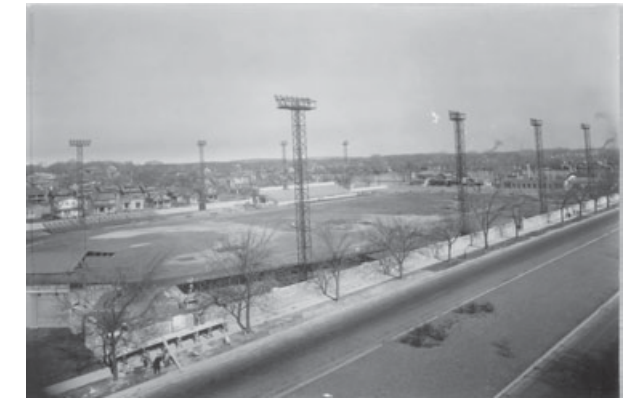
Pictured above is a photograph from the early 1930's that was given to the team for use in this report by the Madison Department of Planning and Development. It depicts the site with its eight light towers standing tall over the athletic field. Masons are shown nearby, presumably placing the stone on the walls. This photograph also shows portable metal bleachers on the north side of the field, as well as the beginning of a section of concrete foundation, which would become an extension of the grandstand, made to accommodate permanent bleacher seating.

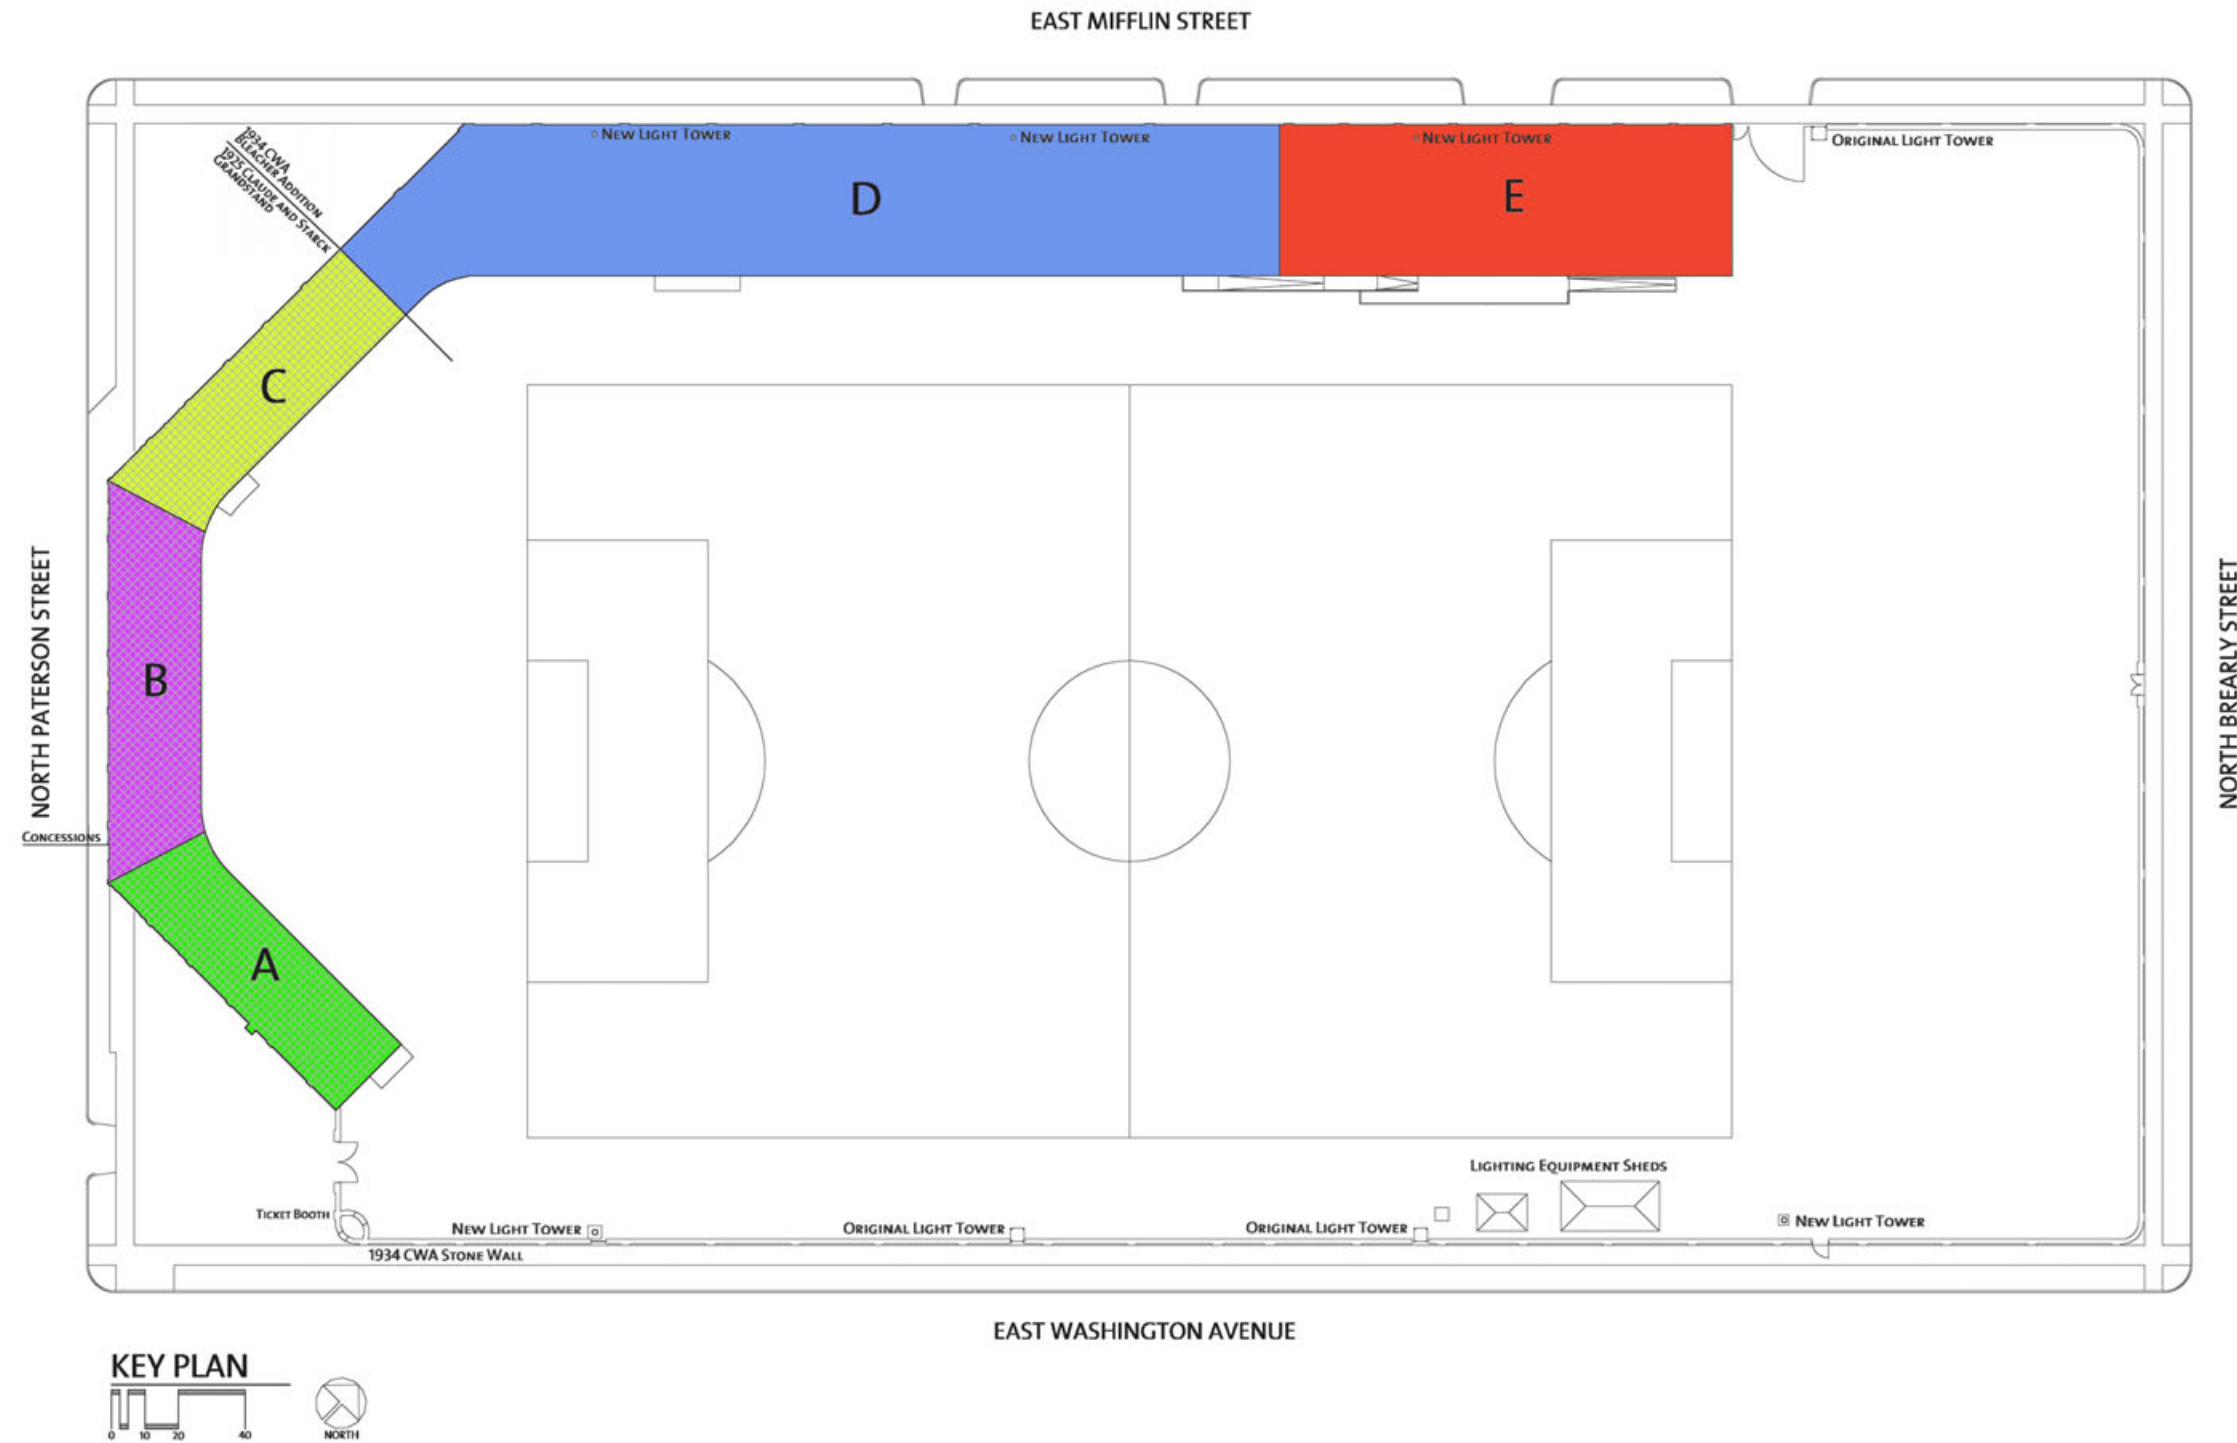
Documentation and Recommendations

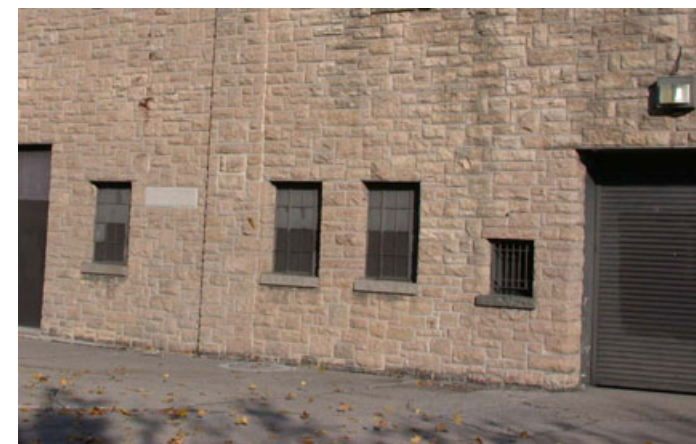
FIGURE 1: Poor concrete walks along the west façade of the grandstand. (2002)

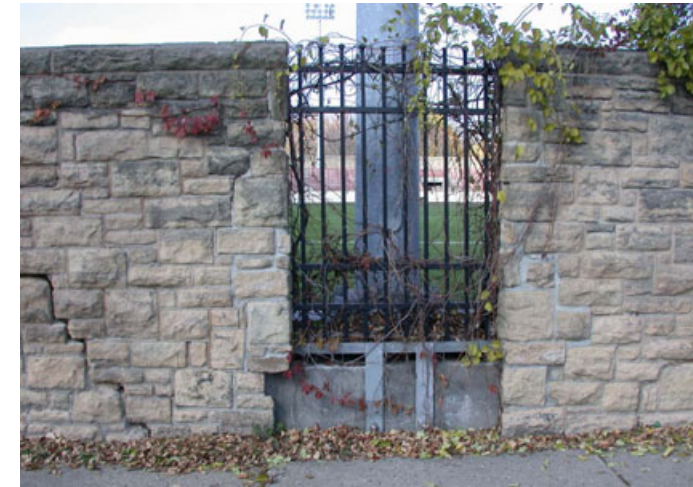
FIGURE 2: Step cracking in the low wall along East Washington Street. (2002)

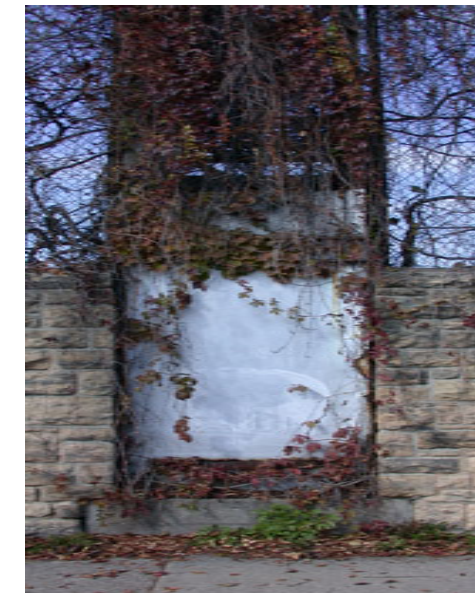
FIGURE 3: Wall opening at one of the light towers along East Washington Street. (2002)

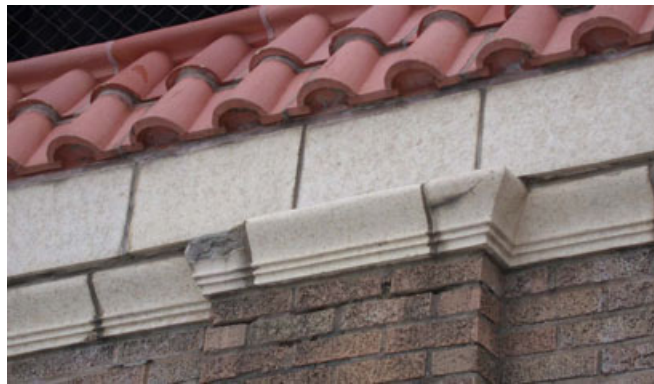
FIGURE 4: Cracked and broken terra cotta pieces and roof tiles on original grandstand section. (2002)

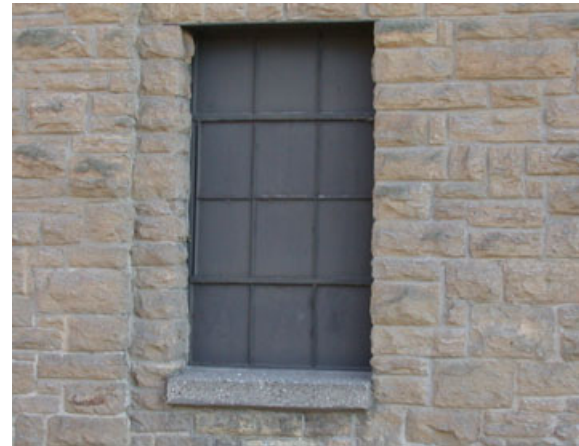
FIGURE 5: Typical steel window. (2002)

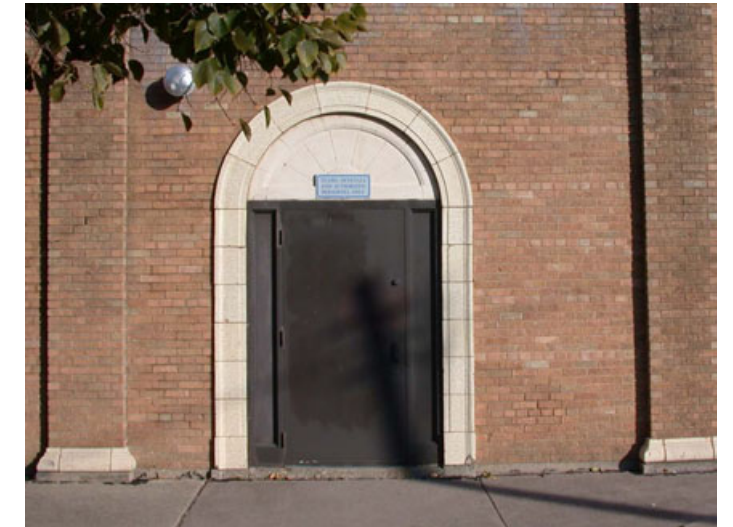
FIGURE 8: Modern entrance door, sidelight and frame. (2002)

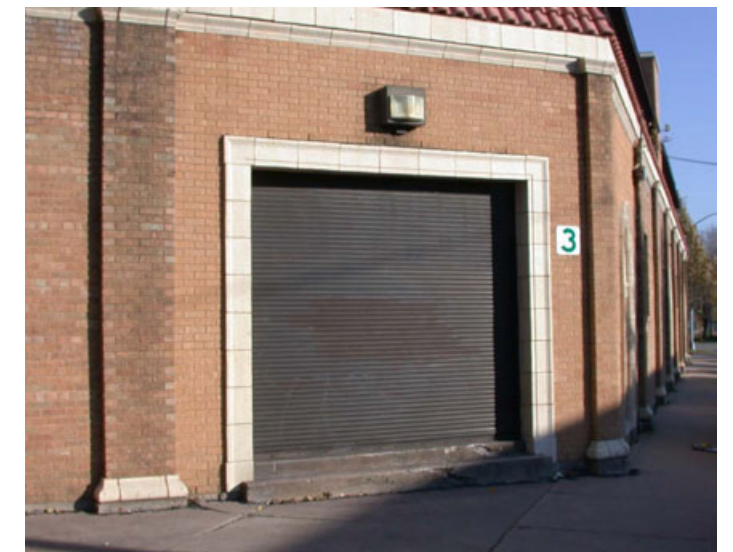
FIGURE 9: Steel roll down door at pedestrian entrances along North Paterson Street. Replace with operable, outswinging gate. (2002)

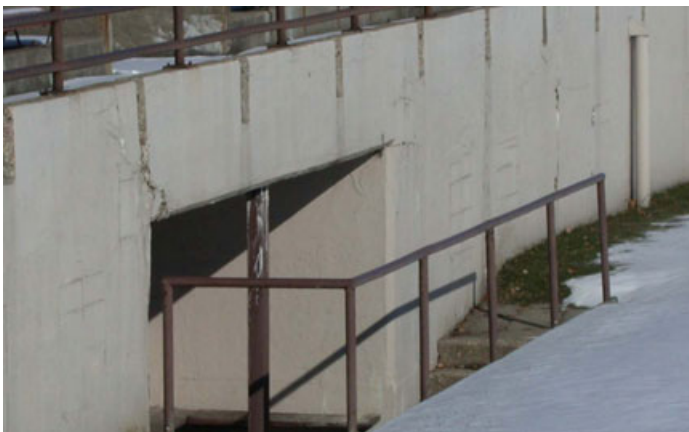
FIGURE 11: Wall damaged from settlement and freeze/thaw cycle. (2002)

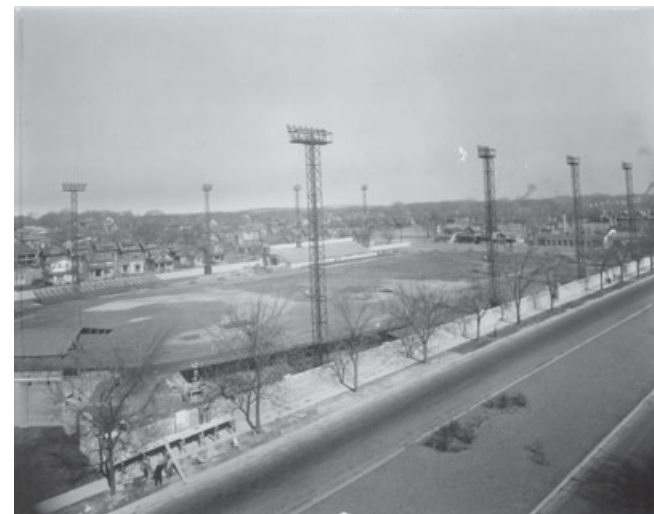
FIGURE 12: Photograph of CWA masons erecting sandstone wall surrounding the field. (1934)

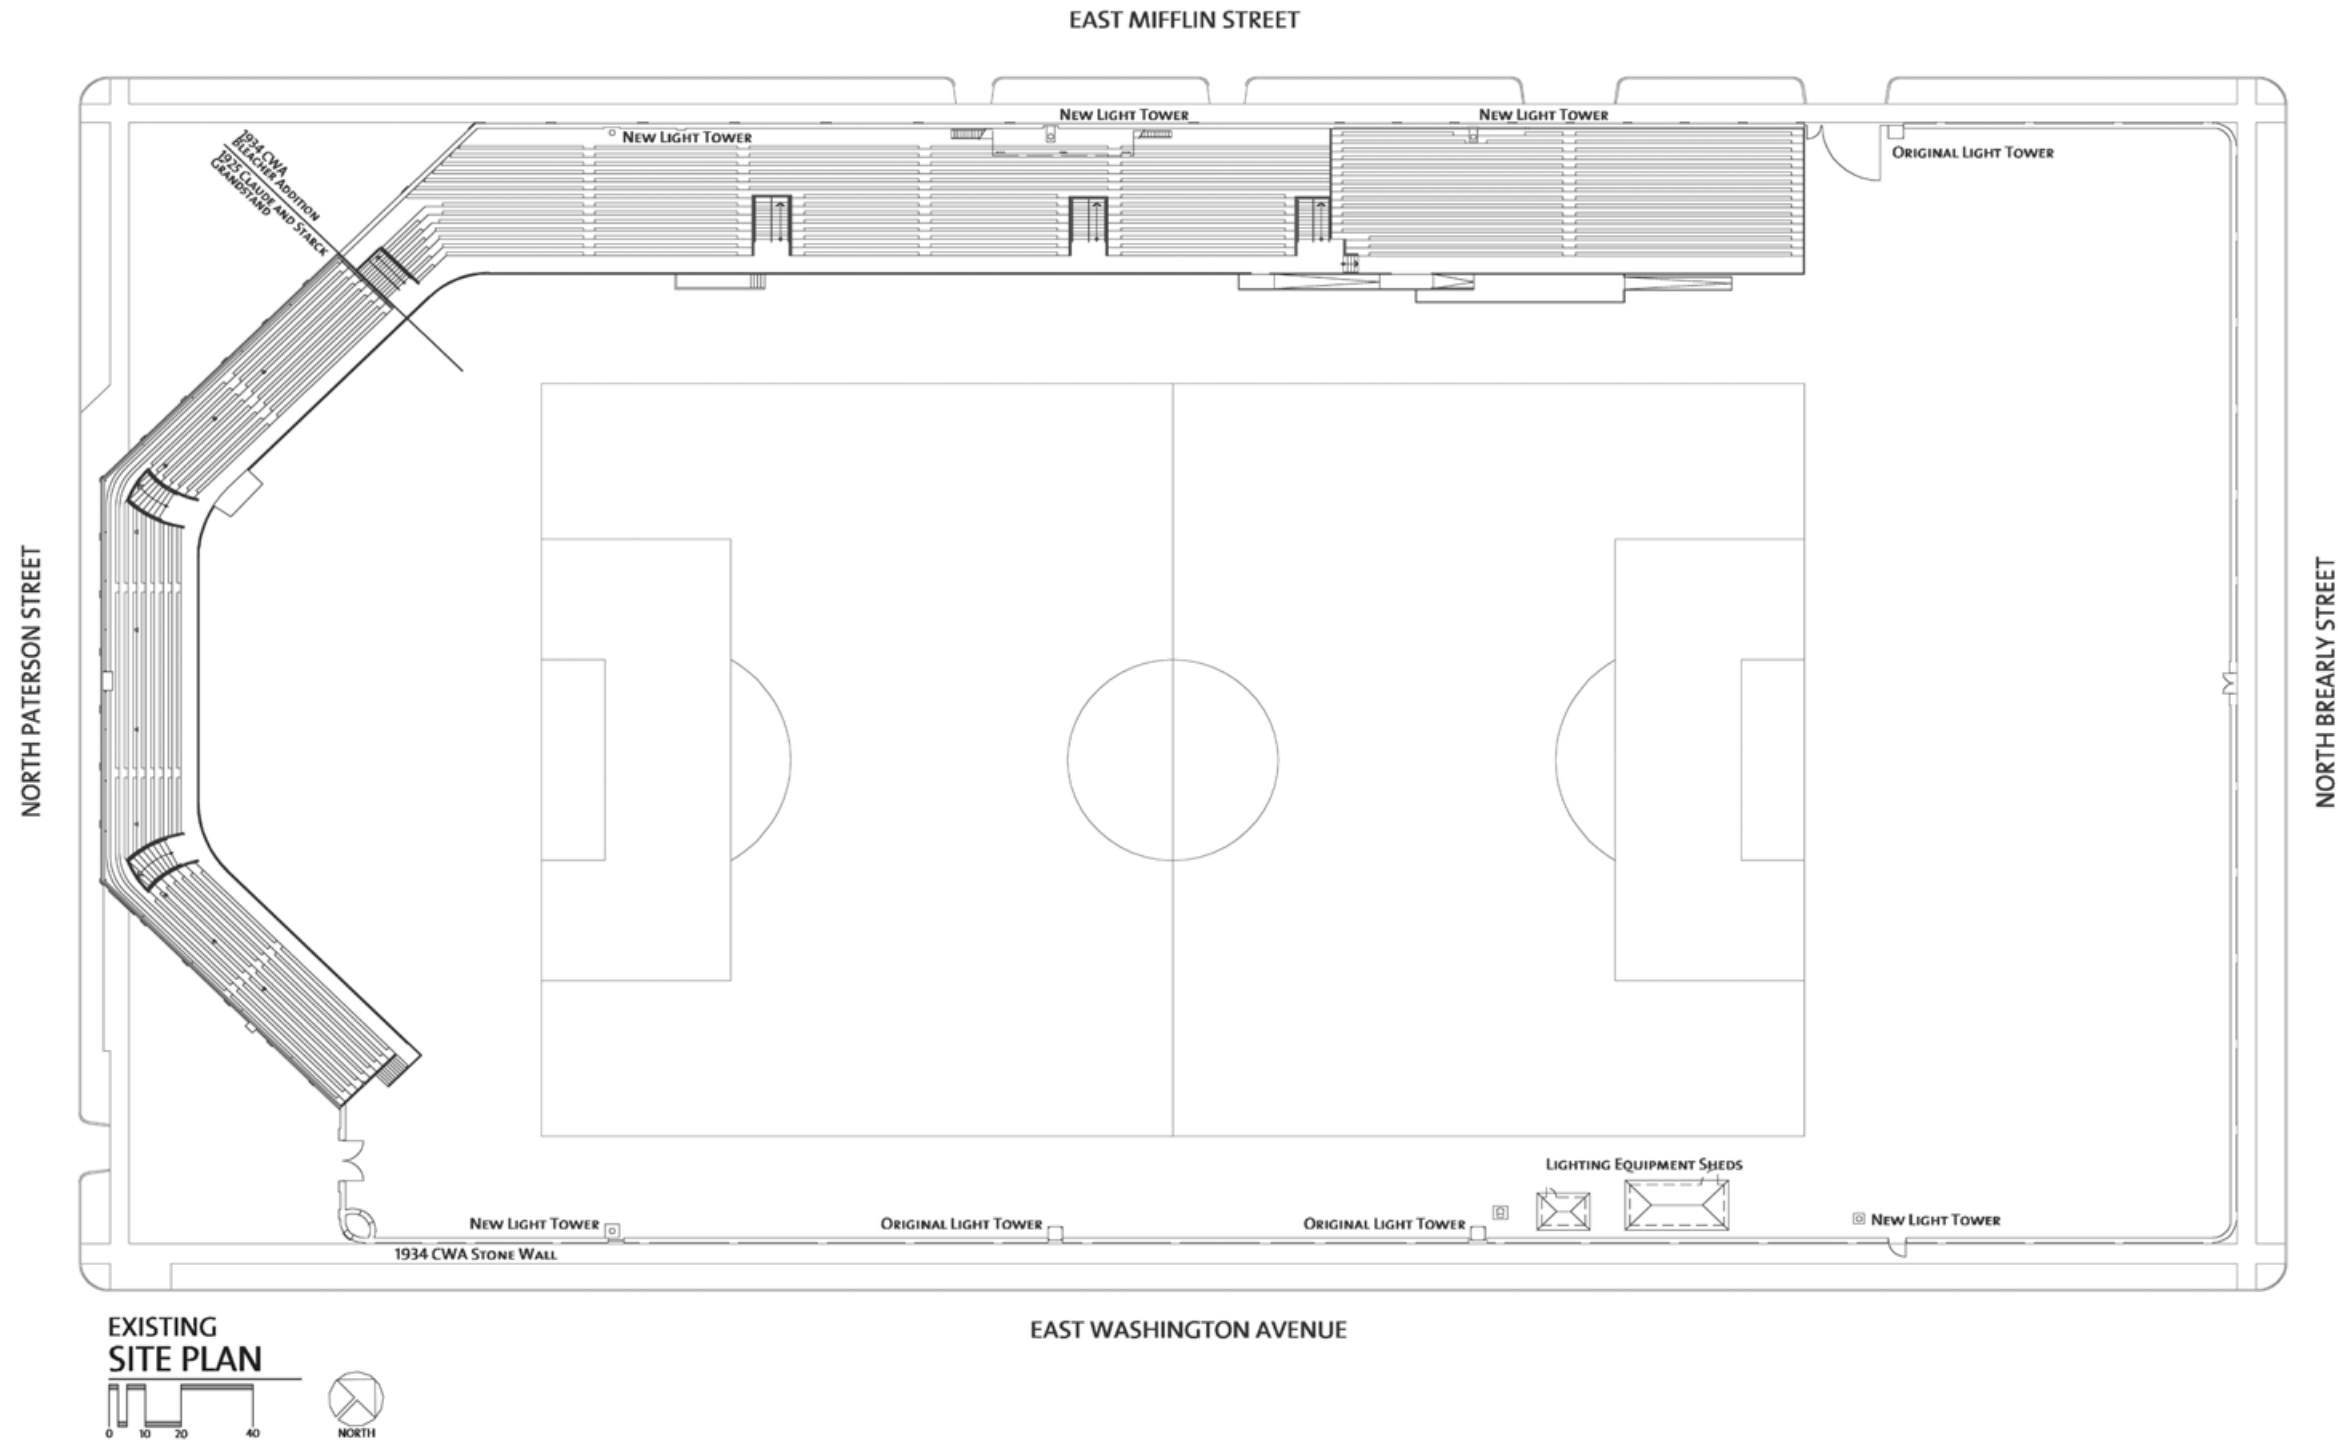
The new rest rooms identified in this section fulfill the code requirements for fixtures needed. These should be constructed of painted concrete block walls and other durable materials that meet the maintenance requirements of the City of Madison.

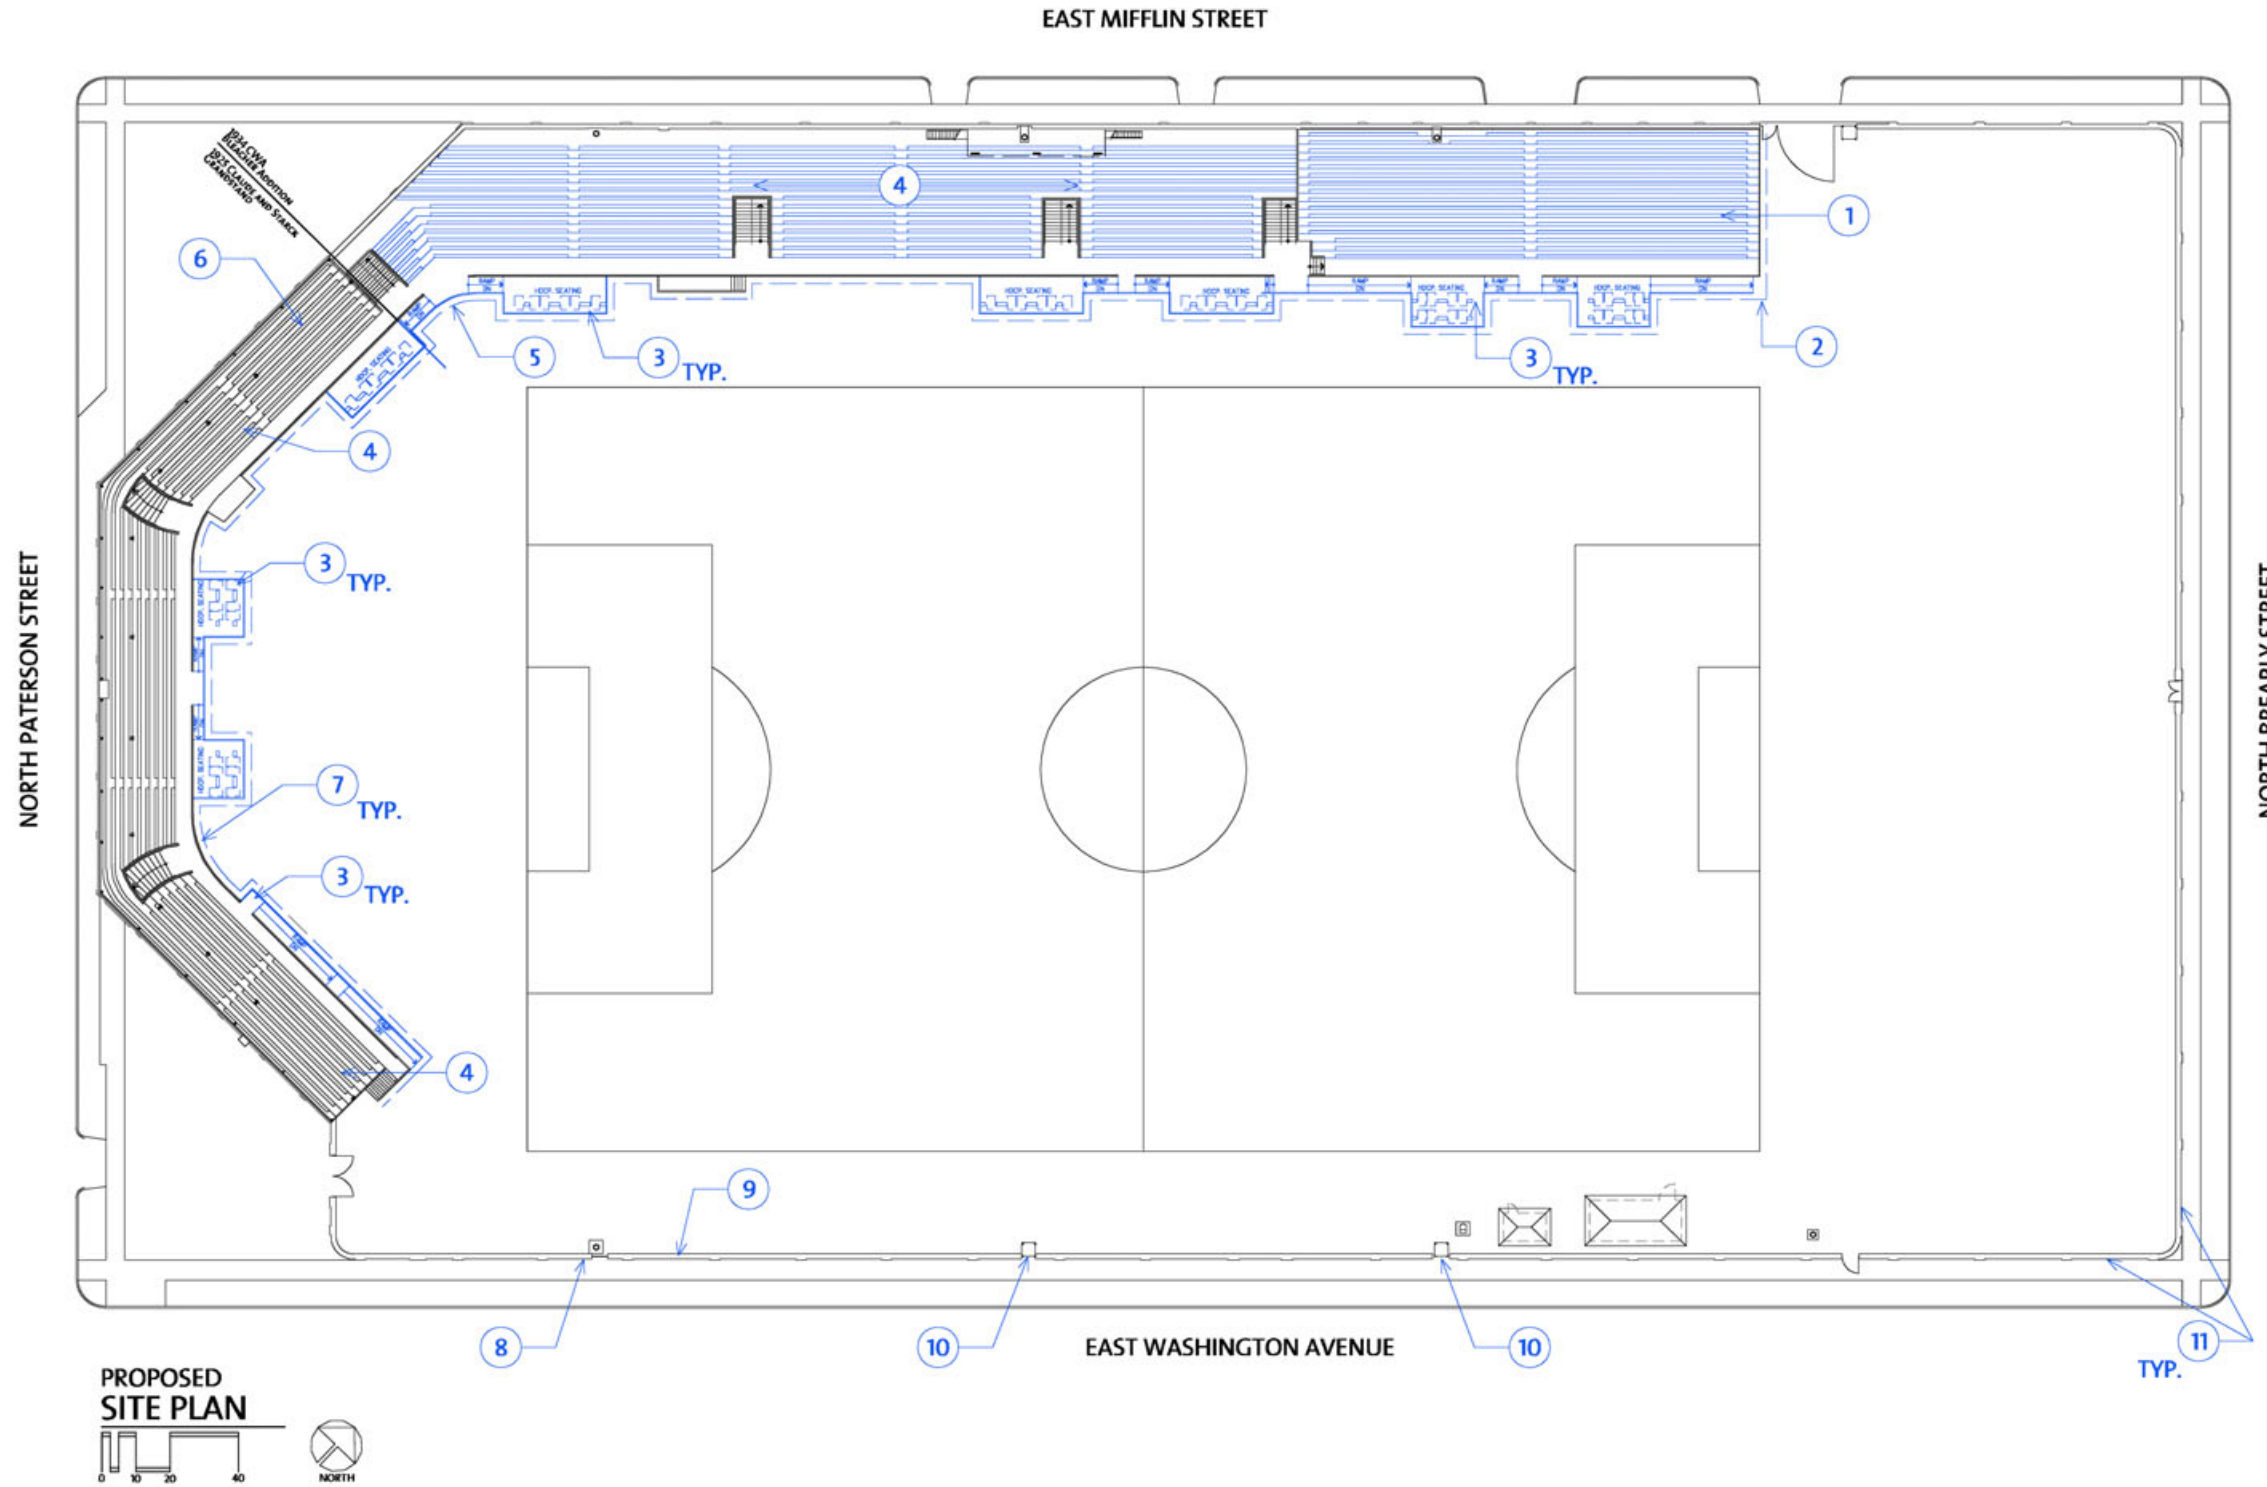
LEGEND
BLACK- EXISTING CONDITIONS
BLUE- PROPOSED WORK

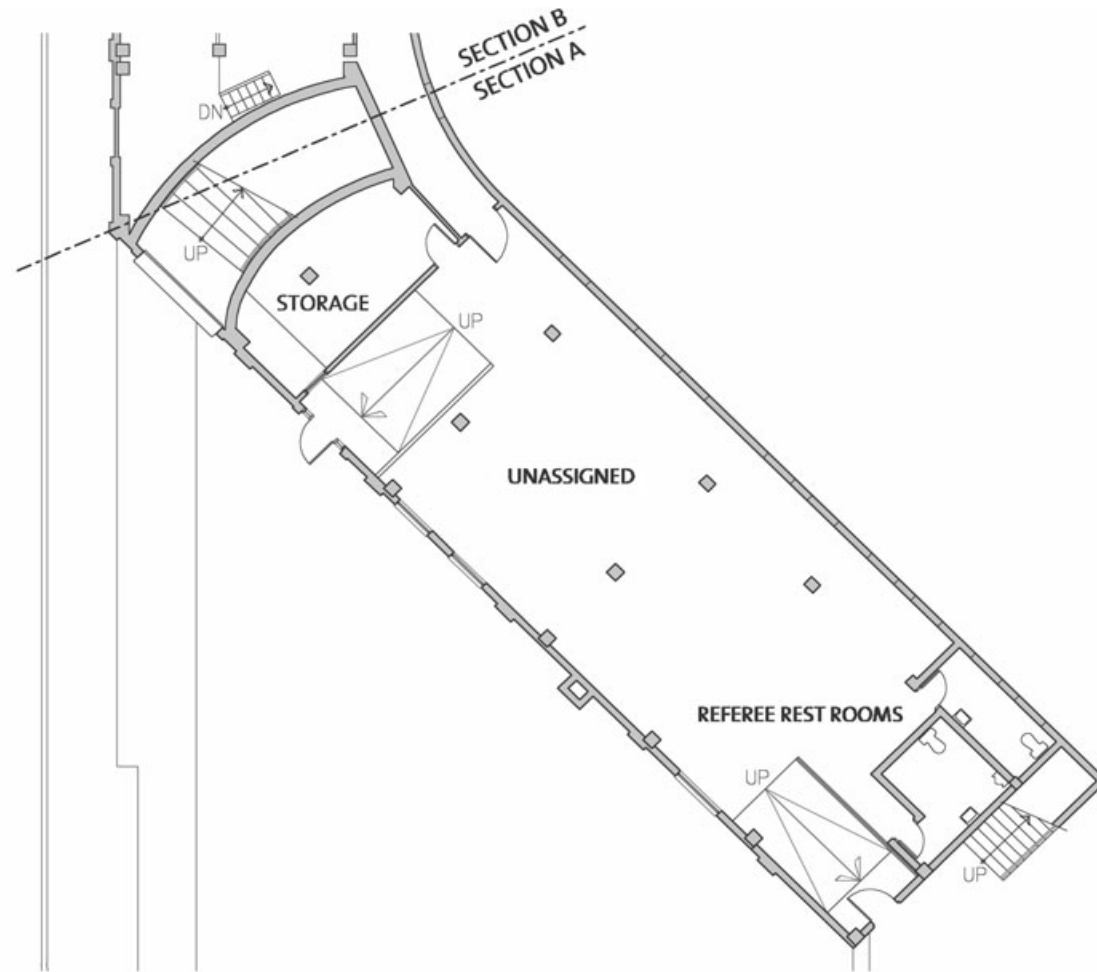
**EXISTING
FLOOR PLAN-SECTION A**

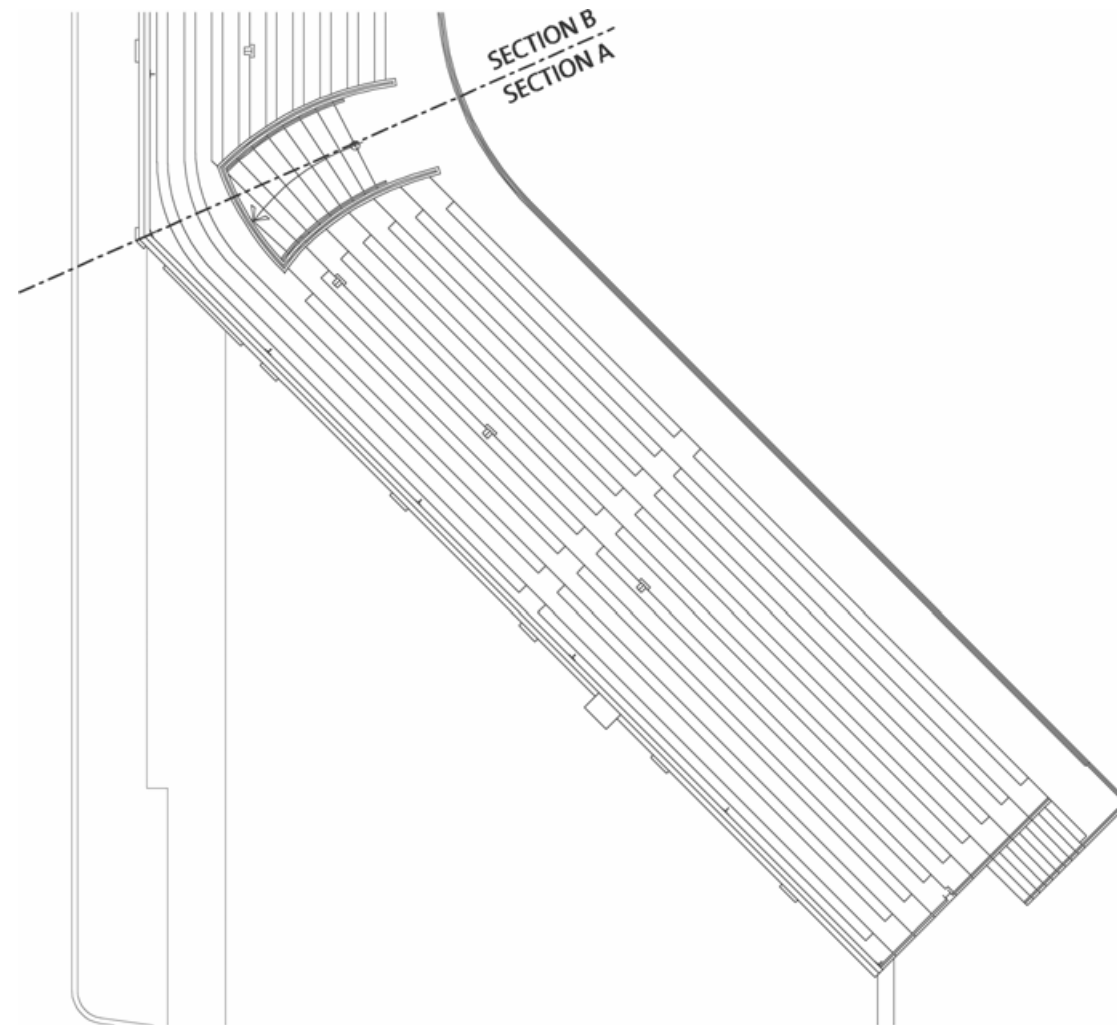
EXISTING
GRANDSTAND PLAN-SECTION A

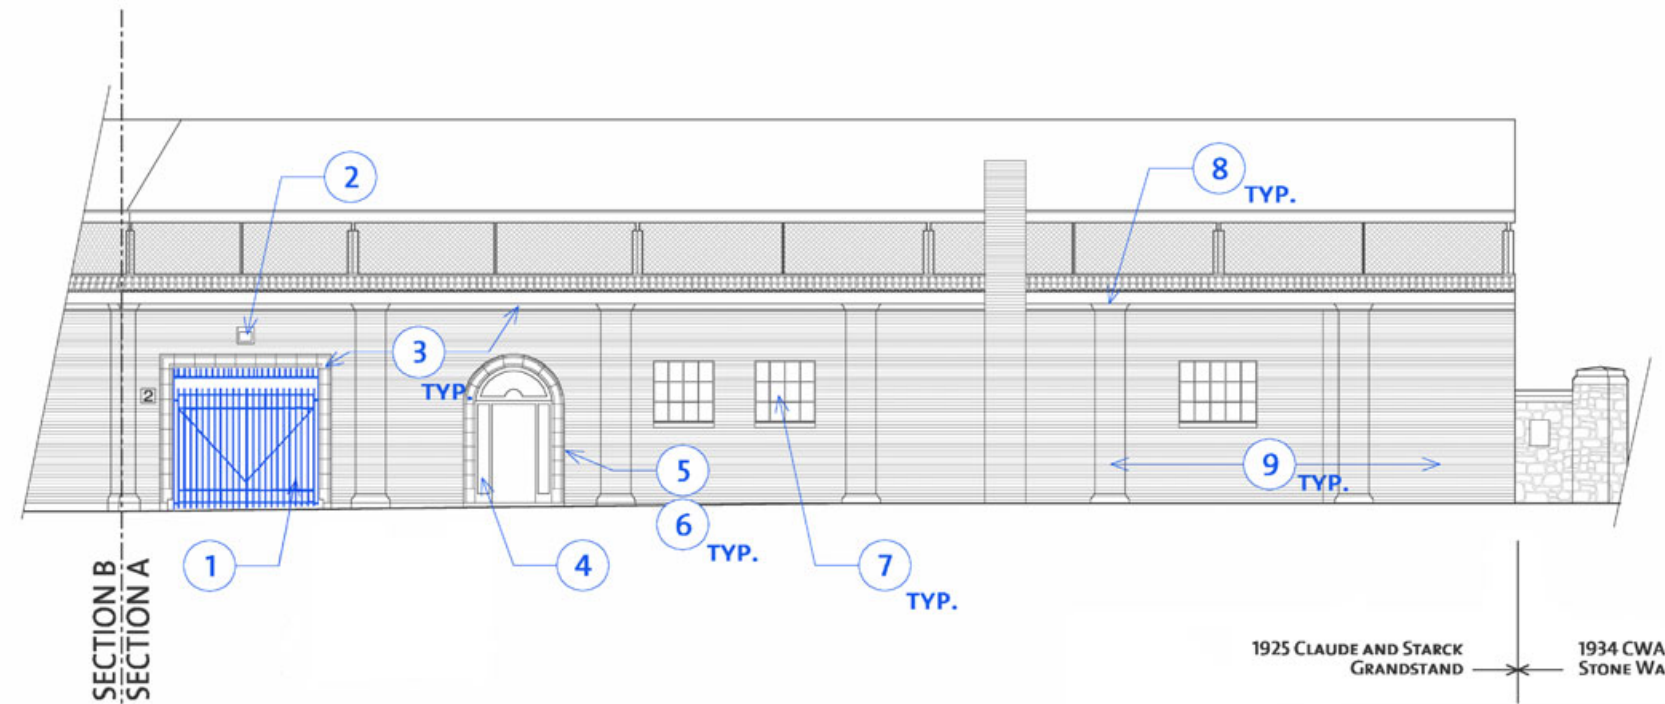
- BLACK- EXISTING CONDITIONS
- BLUE- PROPOSED WORK

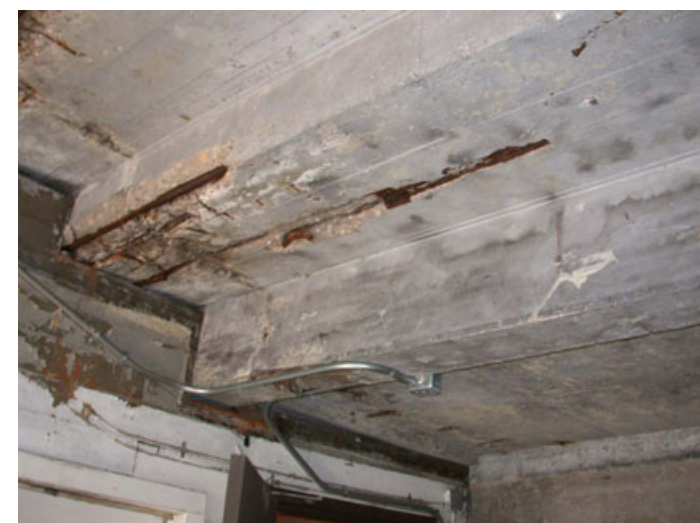
FIGURE 17: Damage to concrete riser slab from water infiltration. (2002)

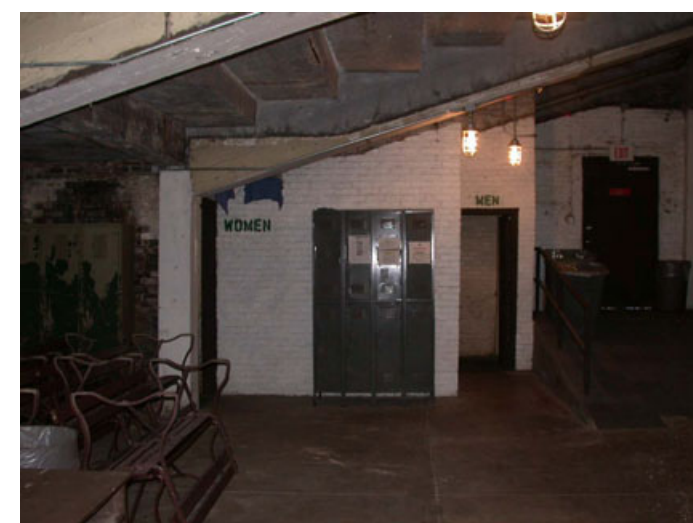
FIGURE 18: Section A view to the east. (2002)

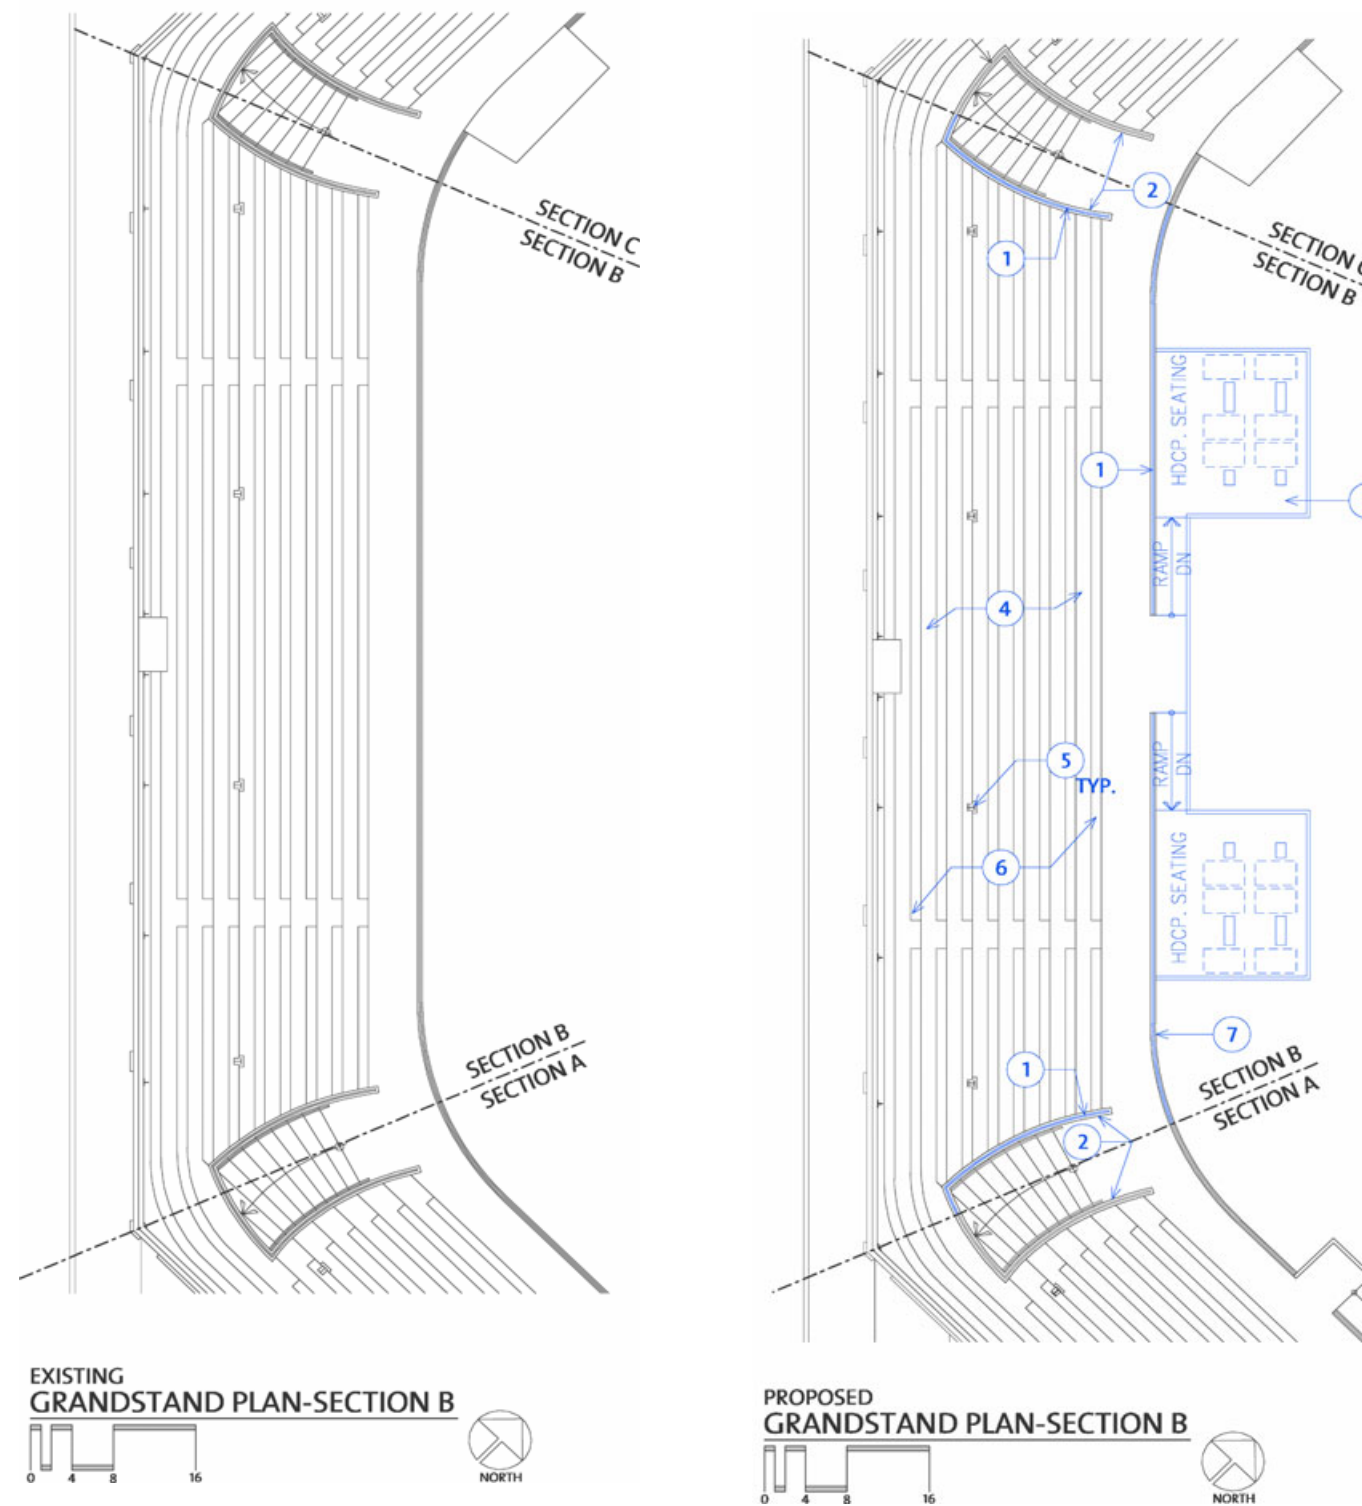
1. Reconstruct lower portion of wall along the field.
2. Construct new secure wall along corridor.
3. Replace rebar and repair concrete deck where required.
4. Paint interior wall and ceiling surfaces, seal concrete floor.
5. Foundation for new accessible seating area.
6. Relocate utility sink. Construct dividing wall between maintenance office and mechanical room.

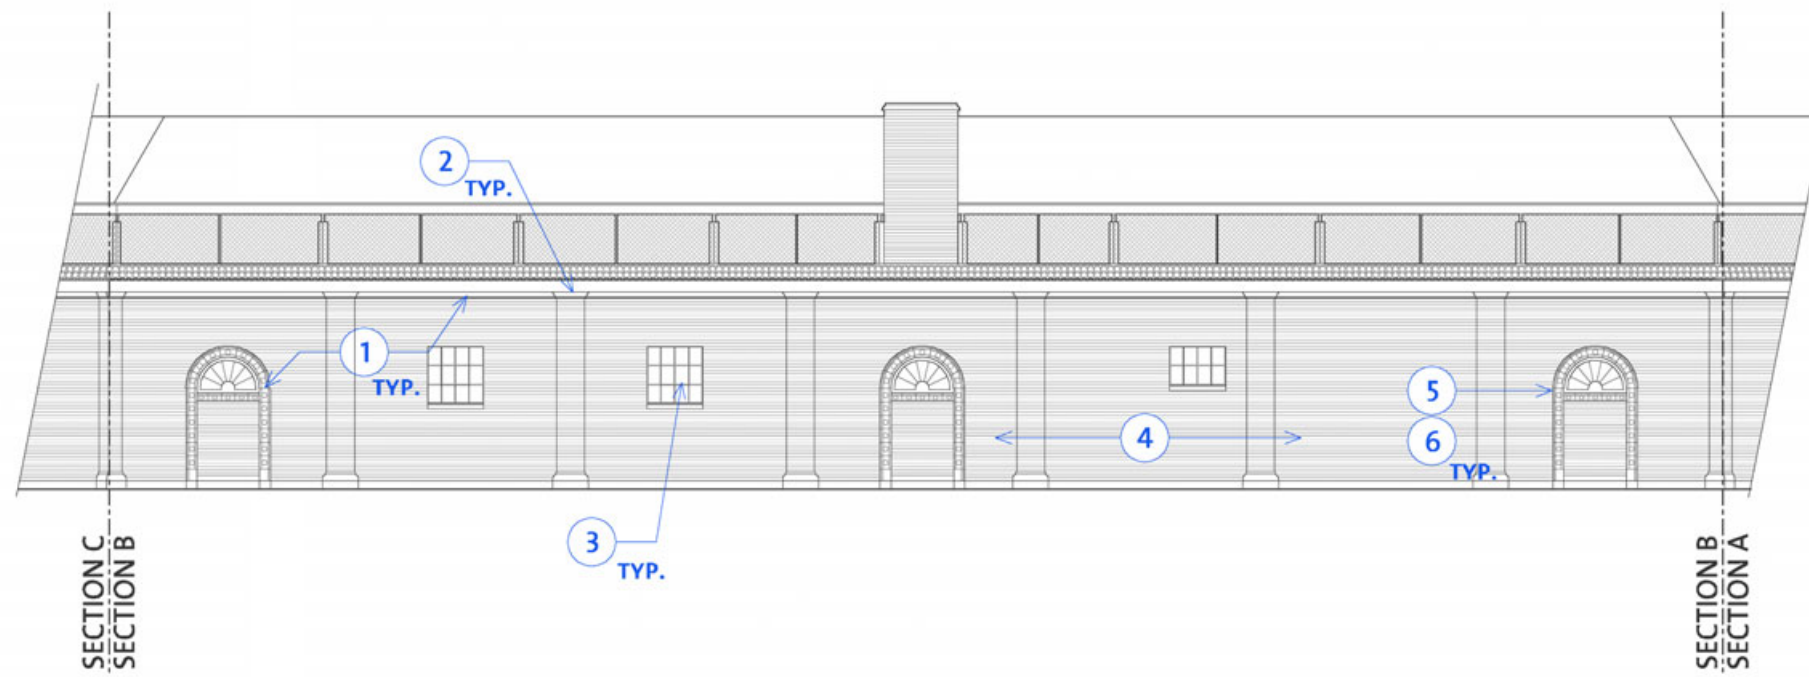
PROPOSED
SOUTHWEST ELEVATION- SECTION B

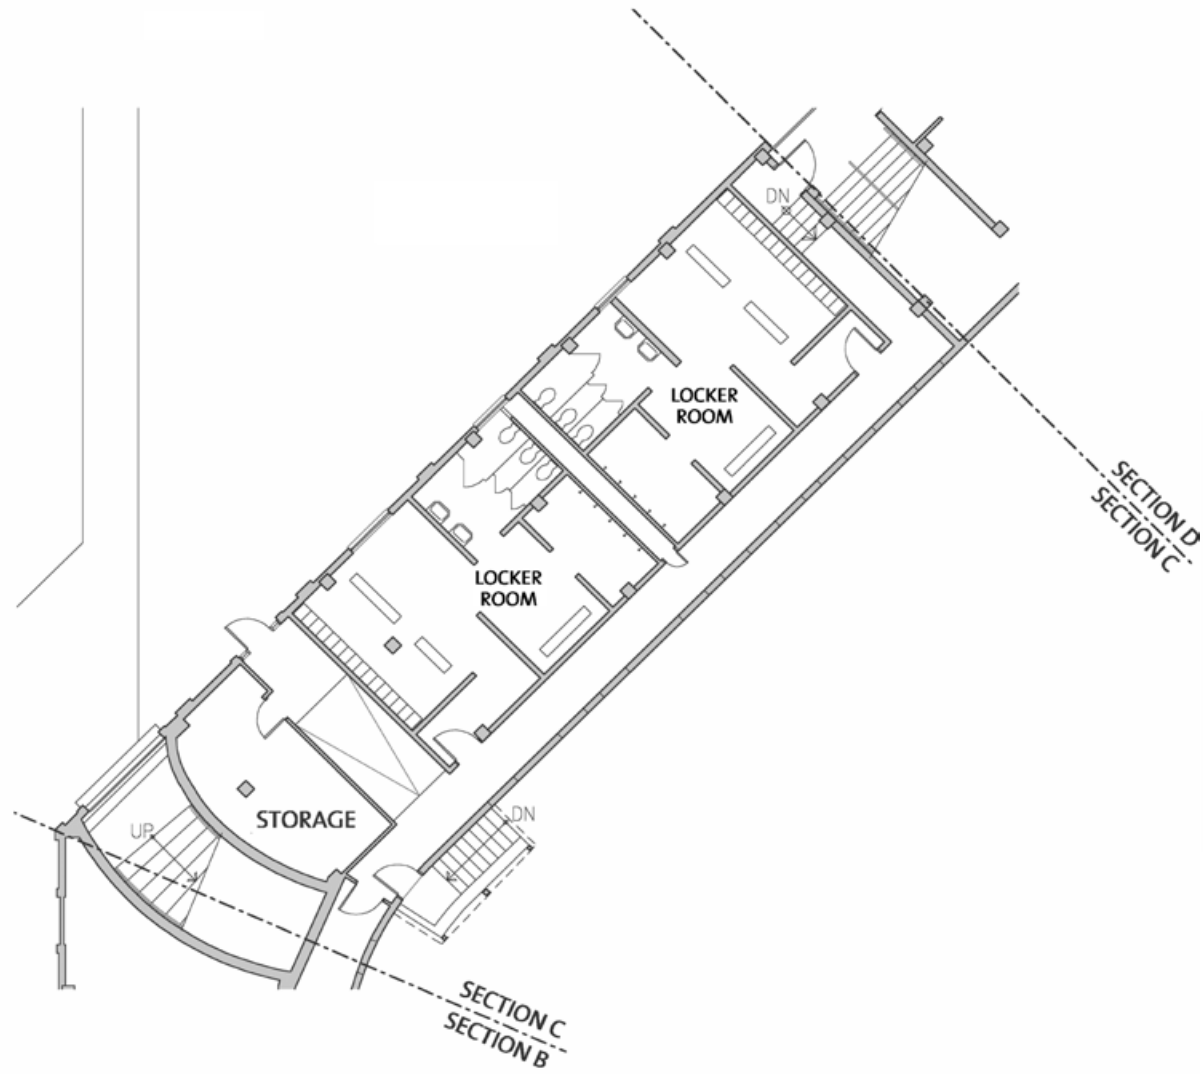
EXISTING
FLOOR PLAN-SECTION C
