BREESE STEVENS FIELD

HISTORIC STRUCTURE REPORT

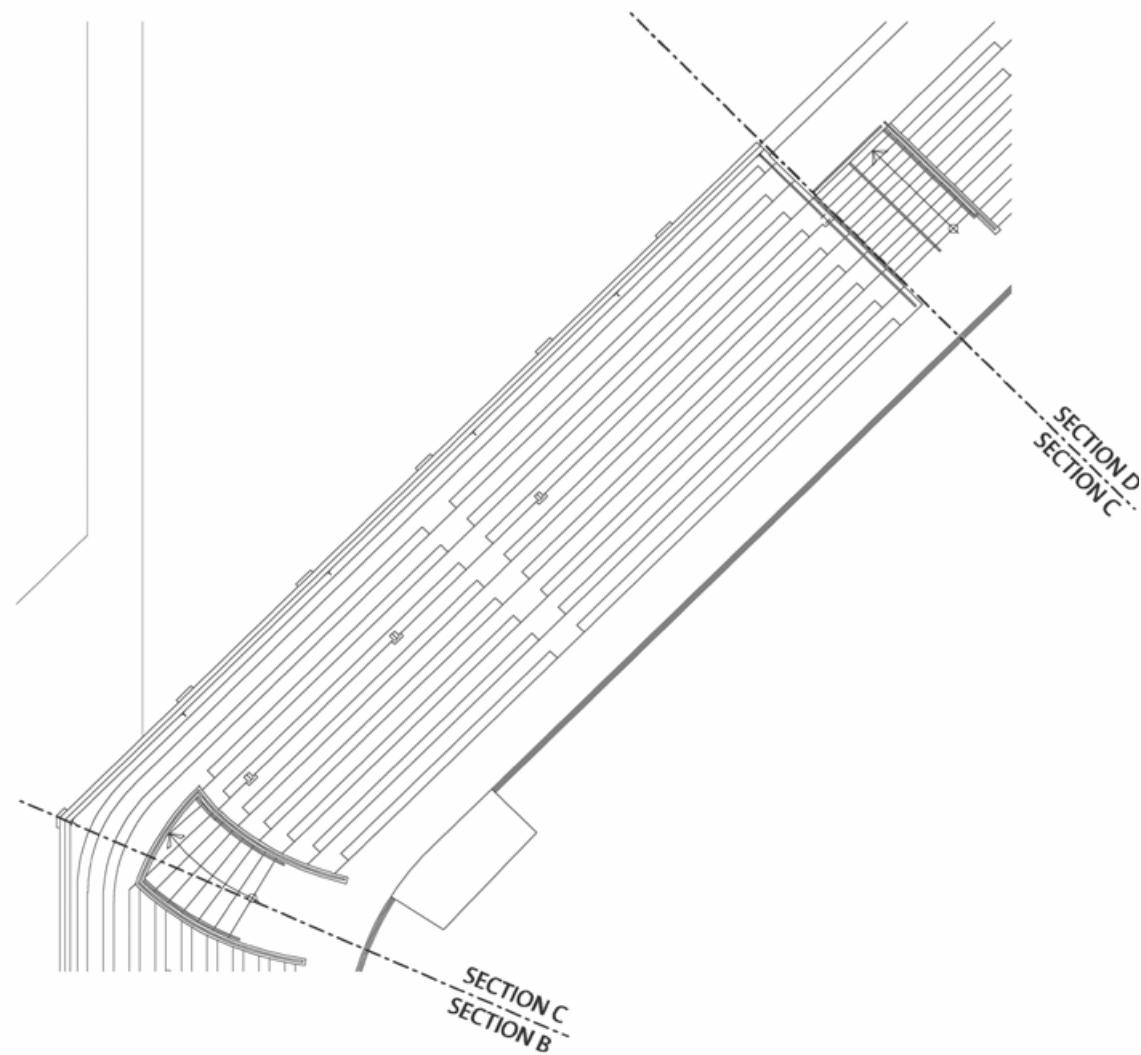
EXISTING
GRANDSTAND PLAN-SECTION C

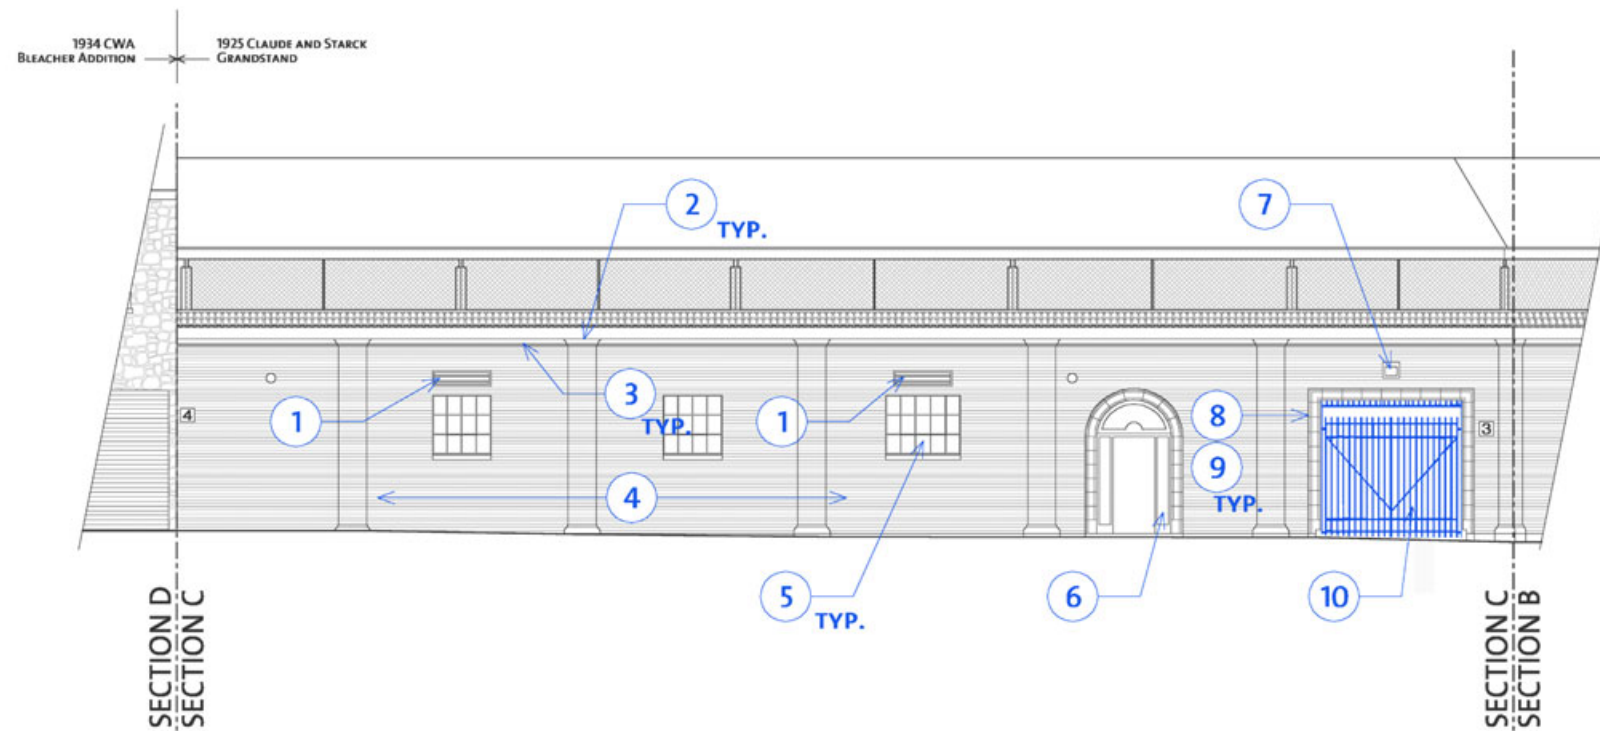
PROPOSED
WEST ELEVATION- SECTION C

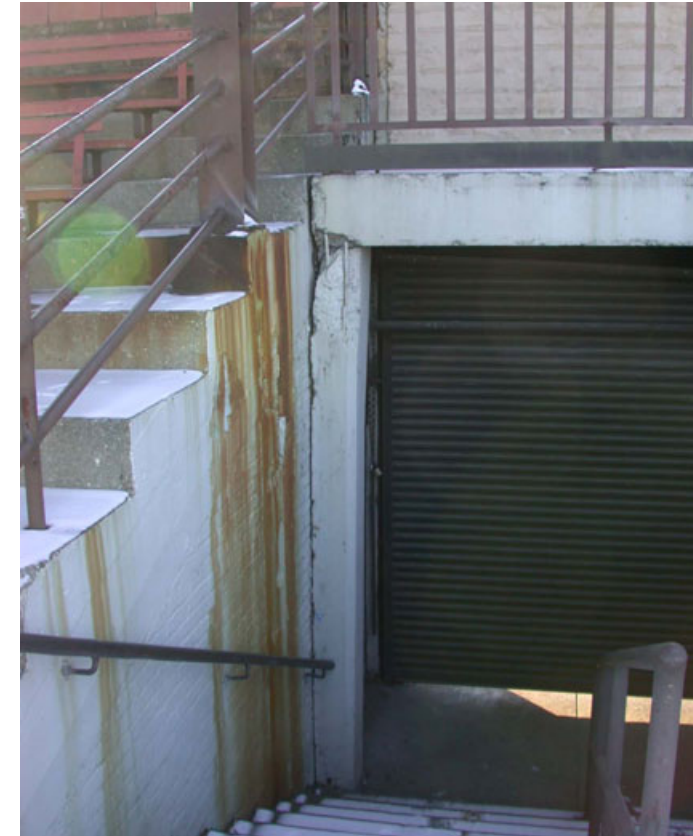
FIGURE 29: Damage to concrete from water infiltration at joints. (2002)

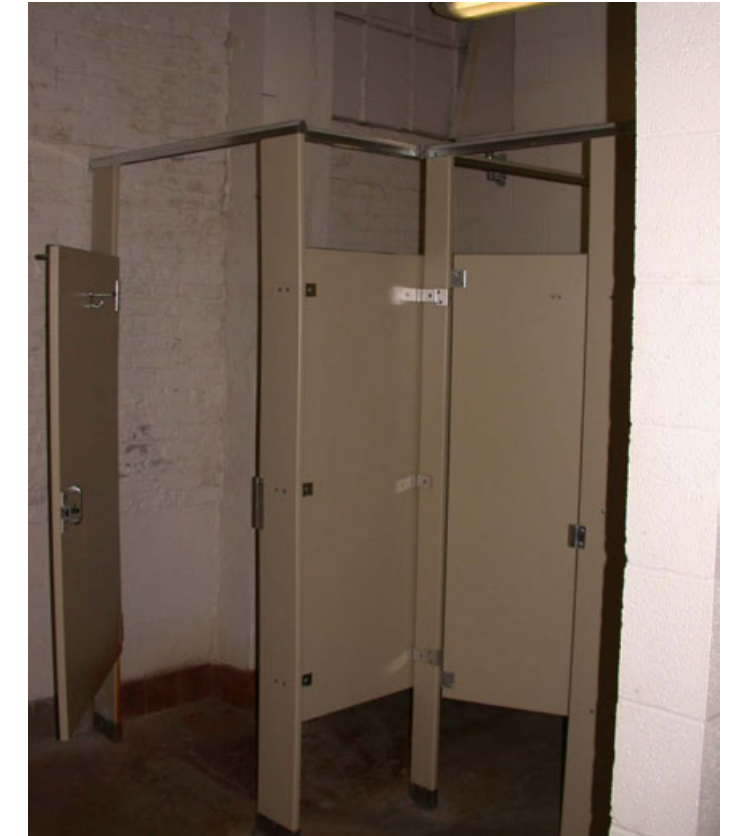
FIGURE 30: Locker room stalls. (2002)

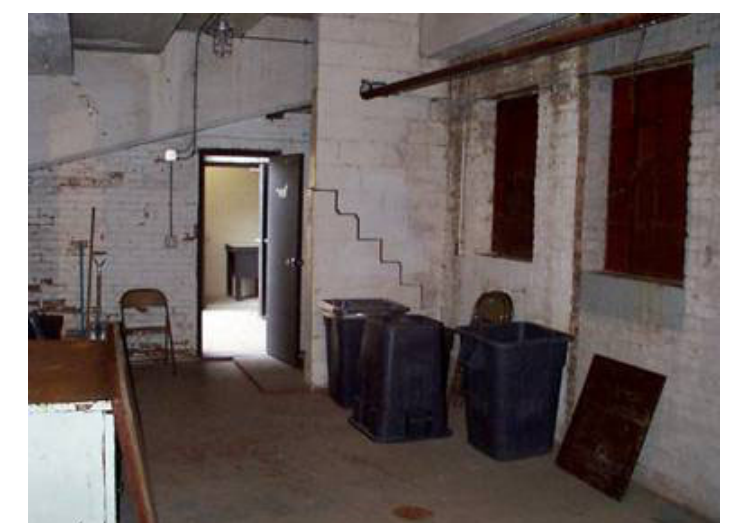
FIGURE 34: Step crack in wall at west ticket booth. (2002)

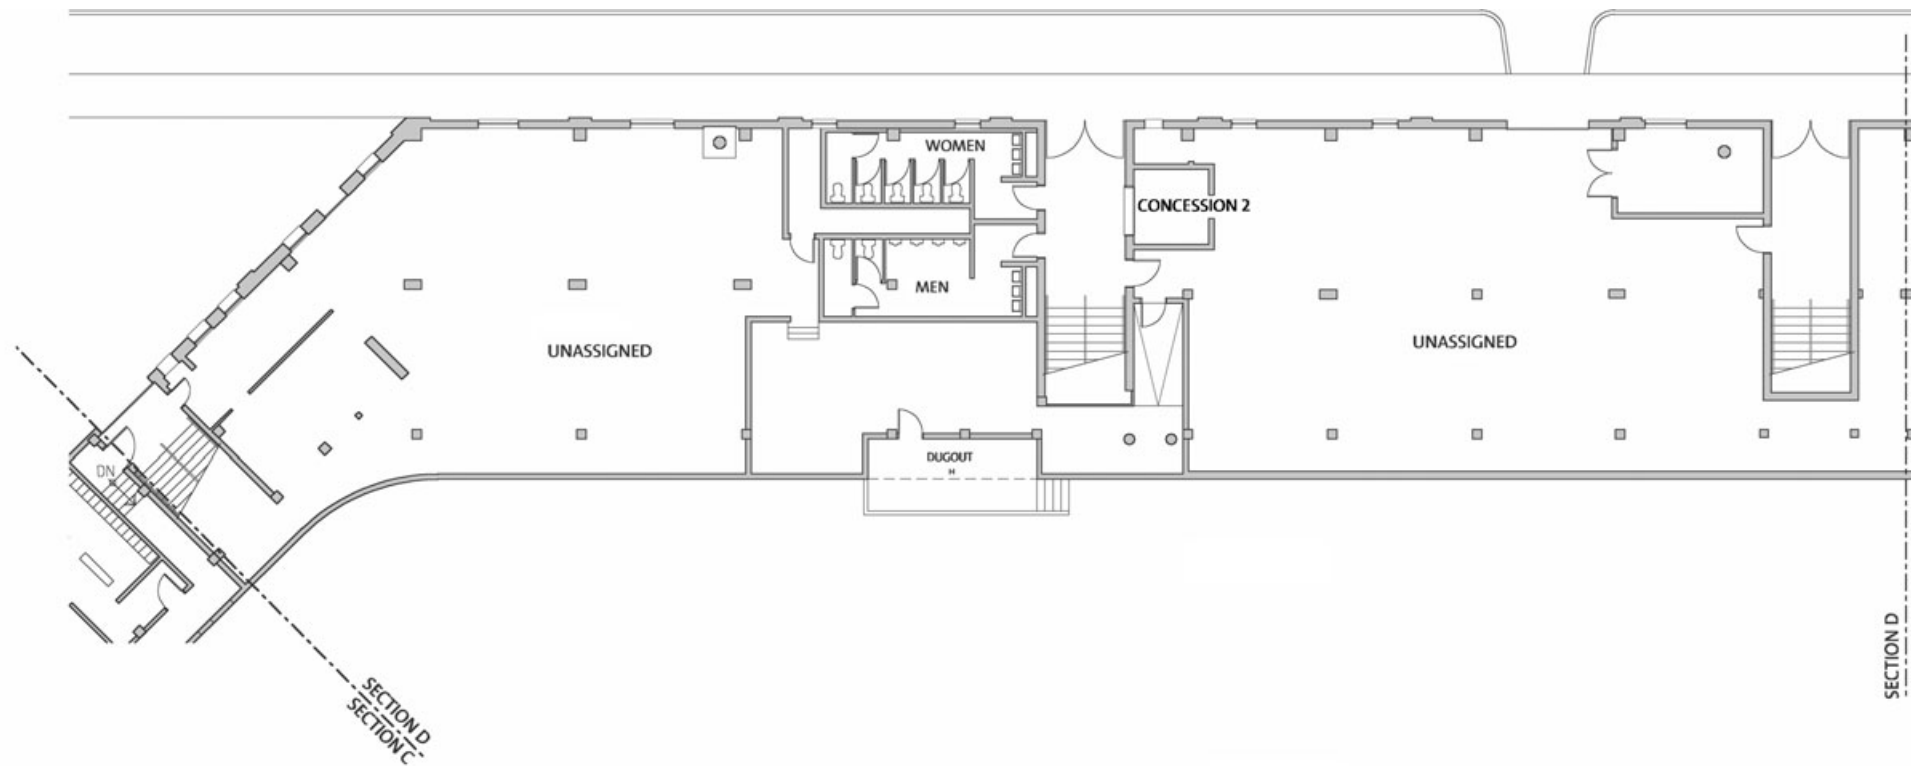
EXISTING
FLOOR PLAN-SECTION D

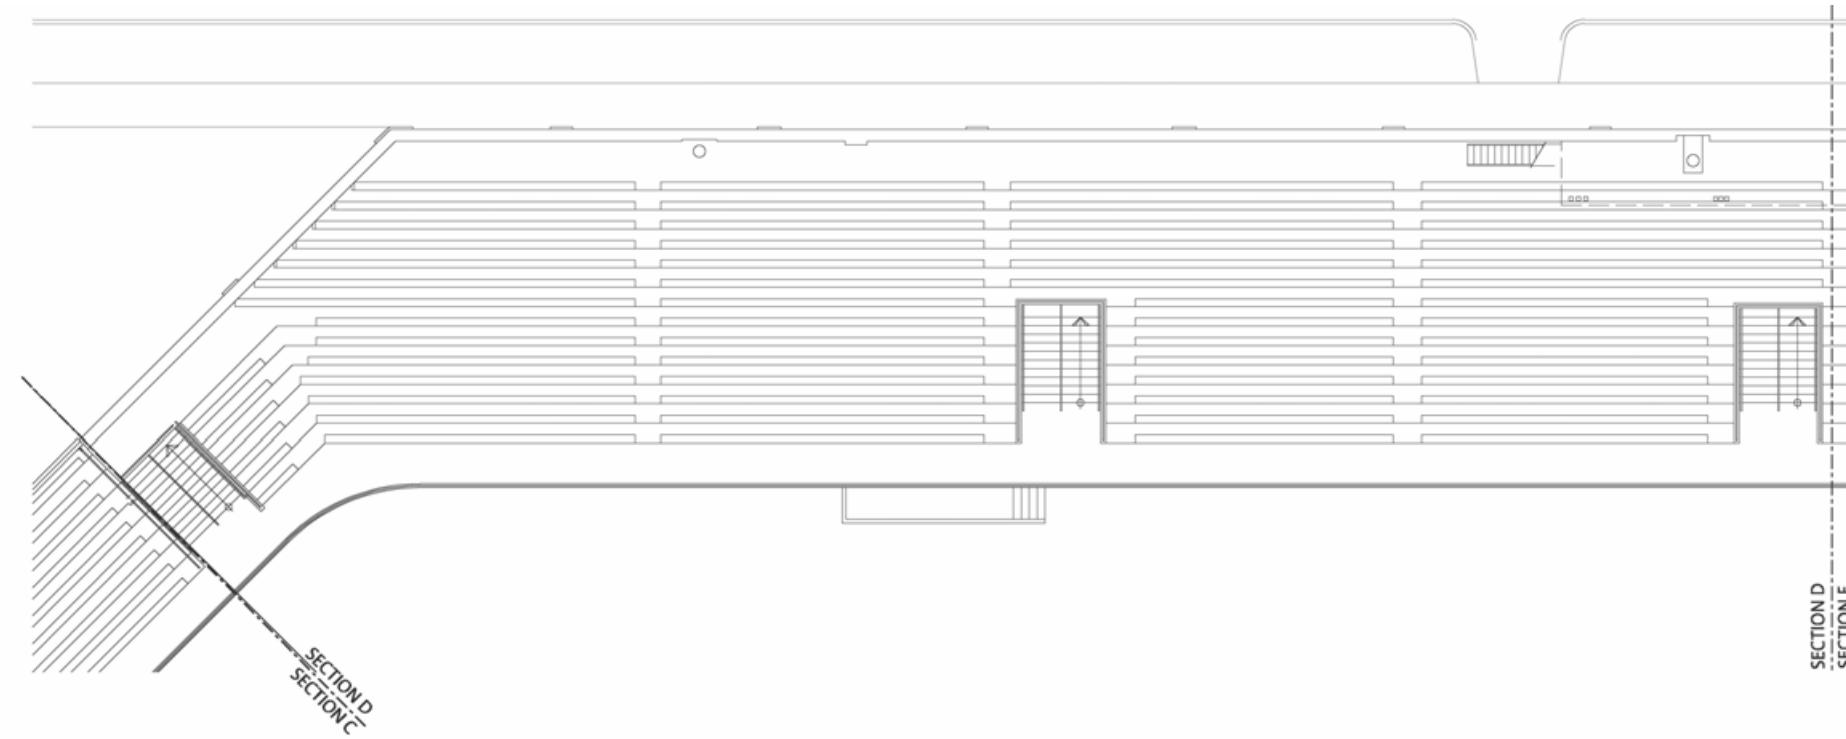
EXISTING
BLEACHER PLAN-SECTION D

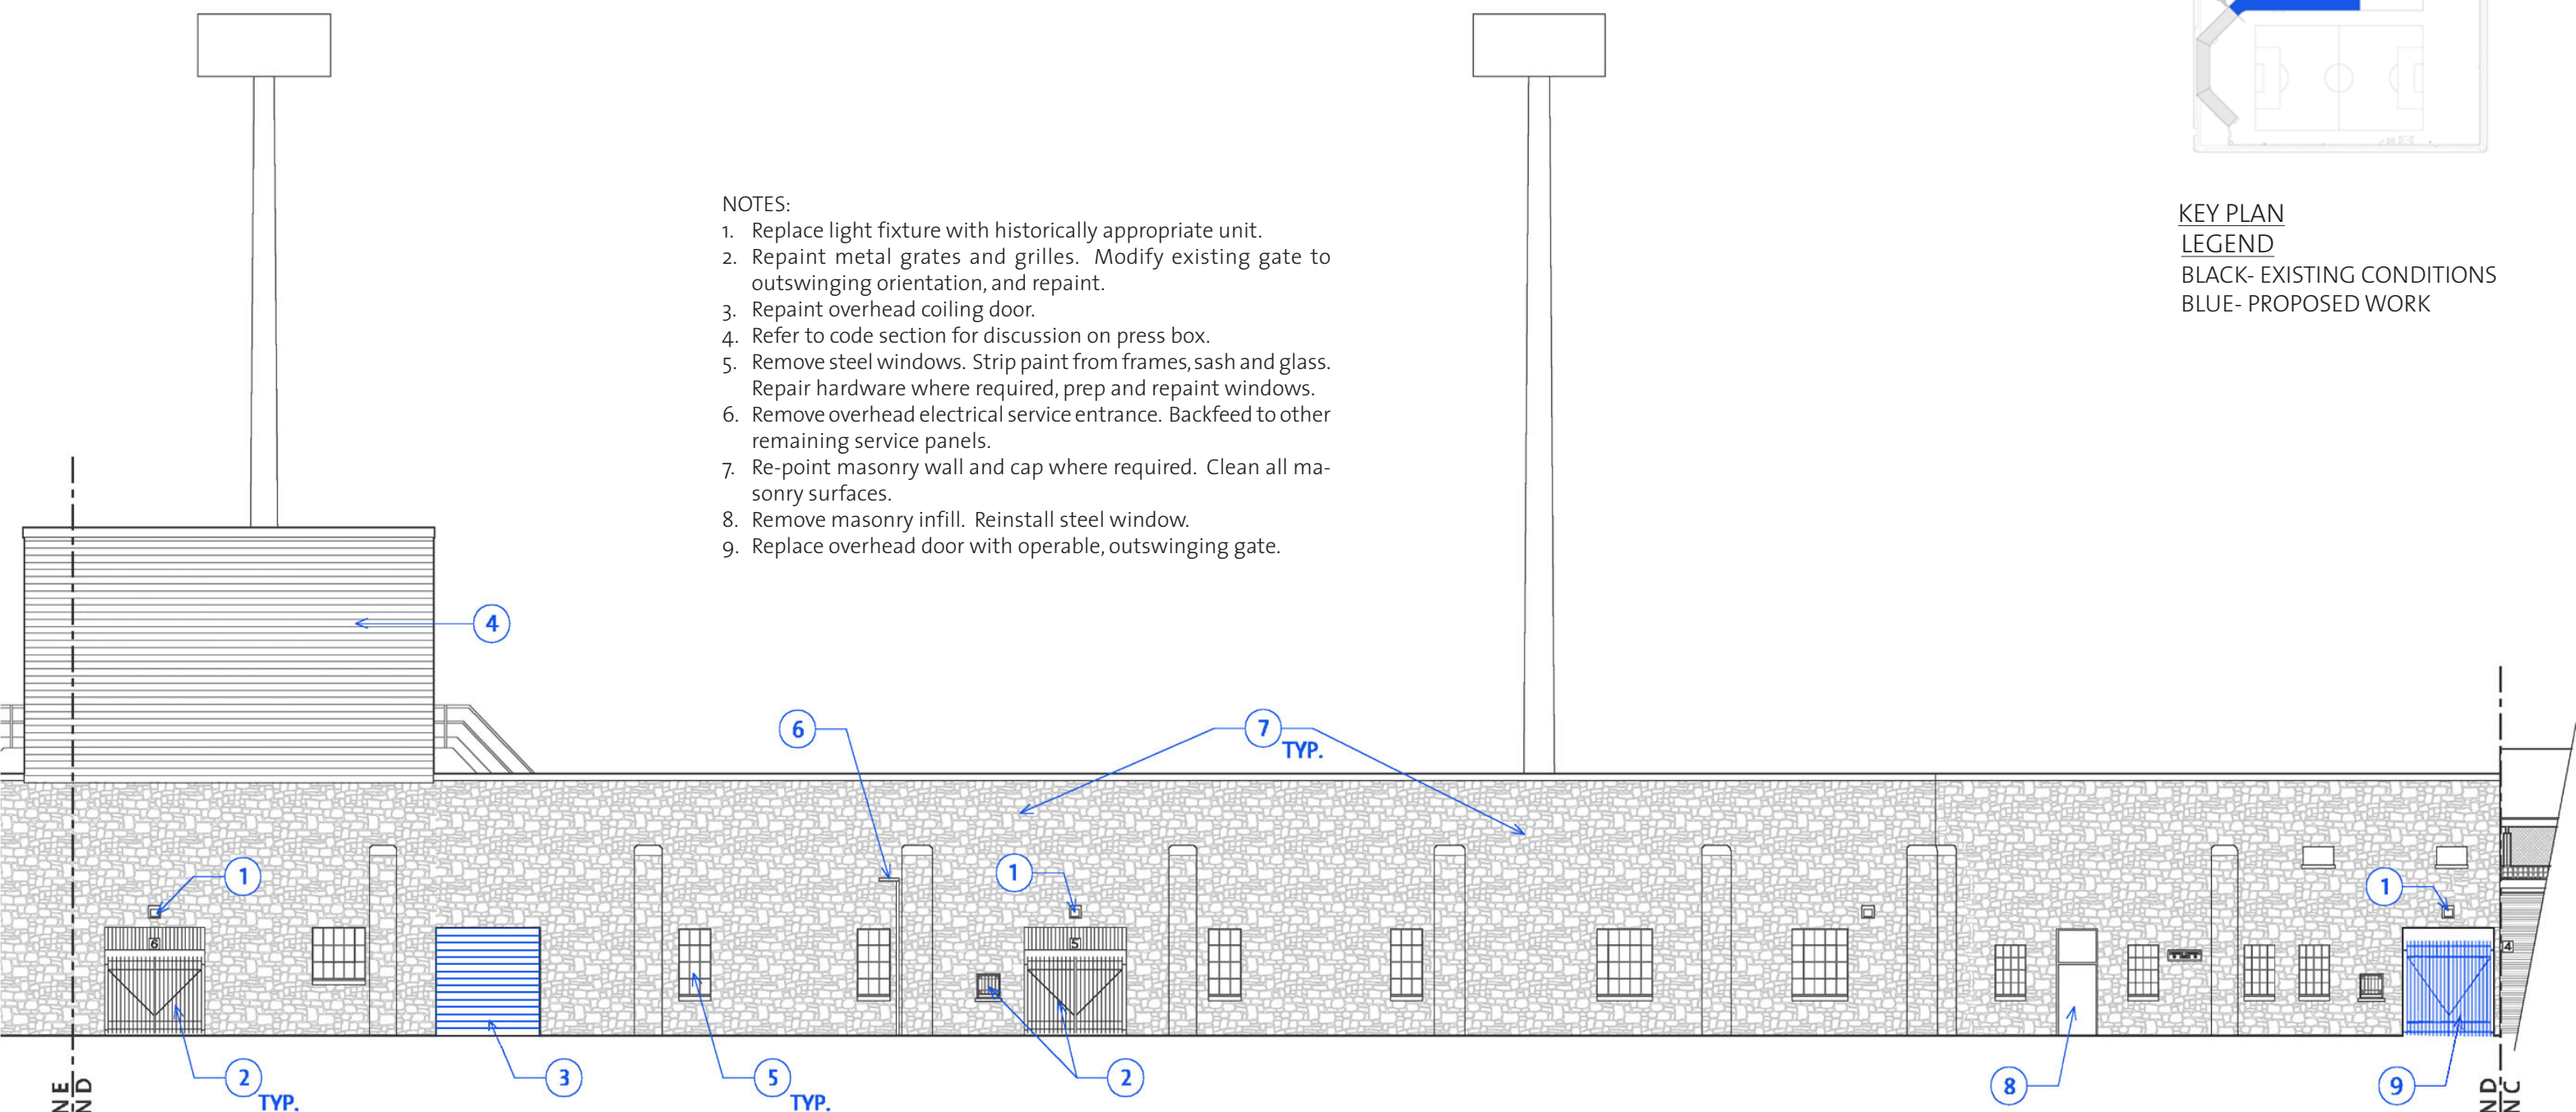
1. Replace light fixture with historically appropriate unit.
2. Repaint metal grates and grilles. Modify existing gate to outswinging orientation, and repaint.
3. Repaint overhead coiling door.
4. Refer to code section for discussion on press box.
5. Remove steel windows. Strip paint from frames, sash and glass. Repair hardware where required, prep and repaint windows.
6. Remove overhead electrical service entrance. Backfeed to other remaining service panels.
7. Re-point masonry wall and cap where required. Clean all masonry surfaces.
8. Remove masonry infill. Reinstall steel window.
9. Replace overhead door with operable, outswinging gate.

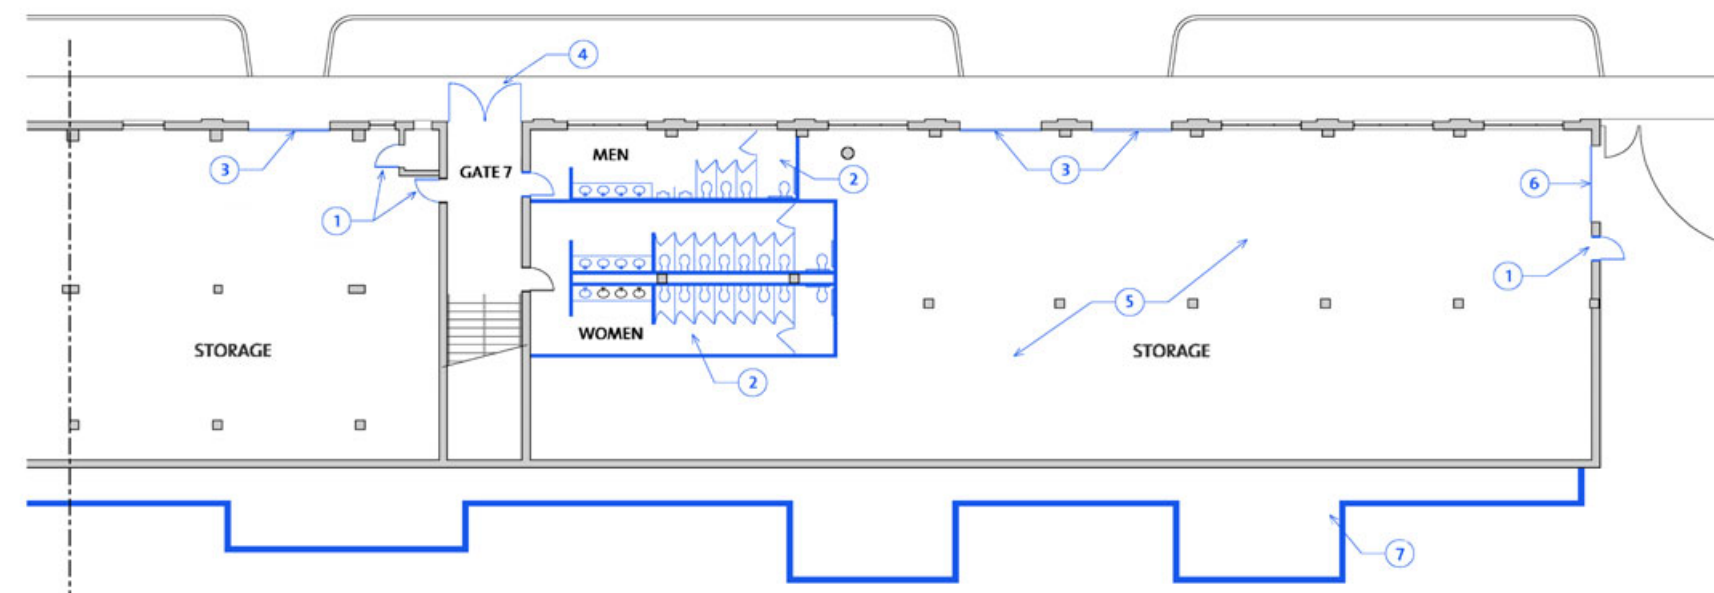
SECTION D
SECTION E
PROPOSED
FLOOR PLAN-SECTION E
0 4 8 16
NORTH

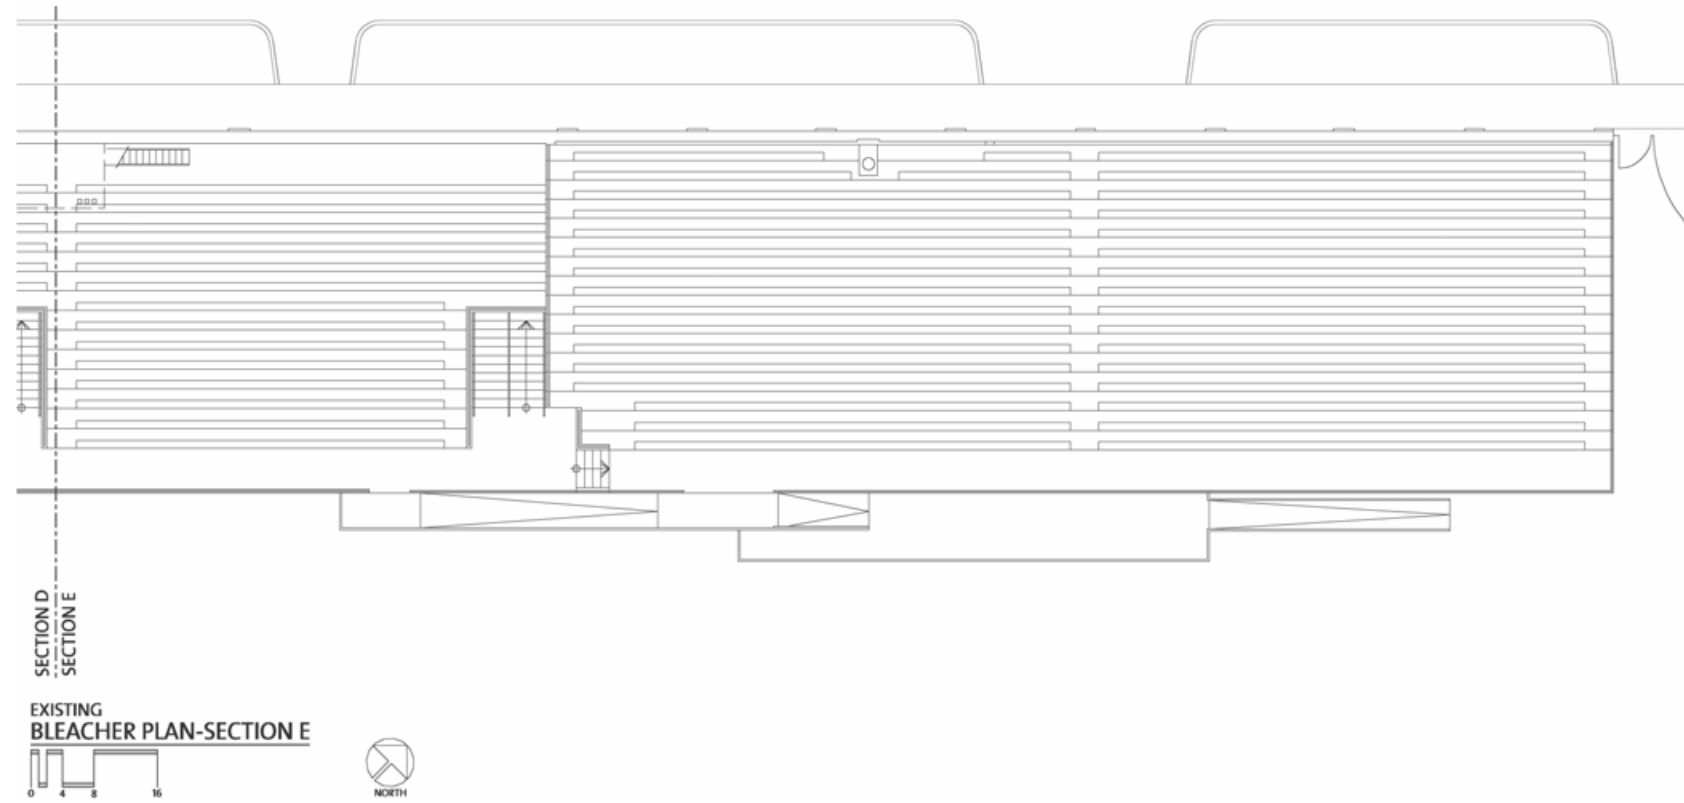
KEY PLAN
LEGEND
BLACK- EXISTING CONDITIONS
BLUE- PROPOSED WORK

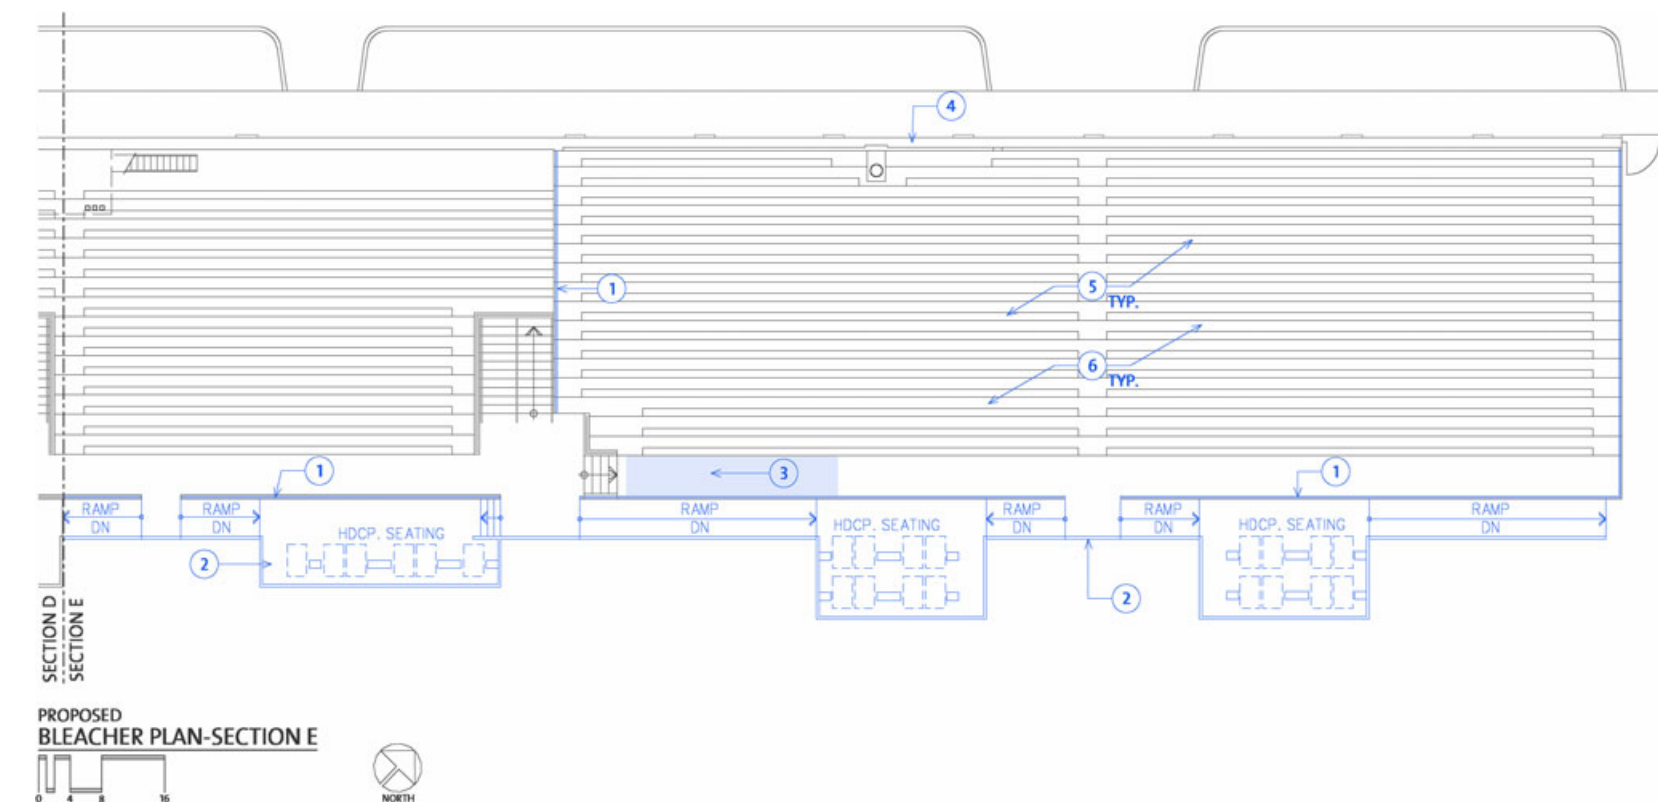
- NOTES:**
1. Repaint handrails.
 2. Remove existing accessible viewing area and construct new area per code.
 3. Replace deteriorated concrete slab.
 4. Re-point wall and cap where necessary.
 5. Replace fiberglass bleachers with code compliant and historically appropriate type.
 6. Repair concrete risers and joints. Cover the slab with waterproof membrane coating.

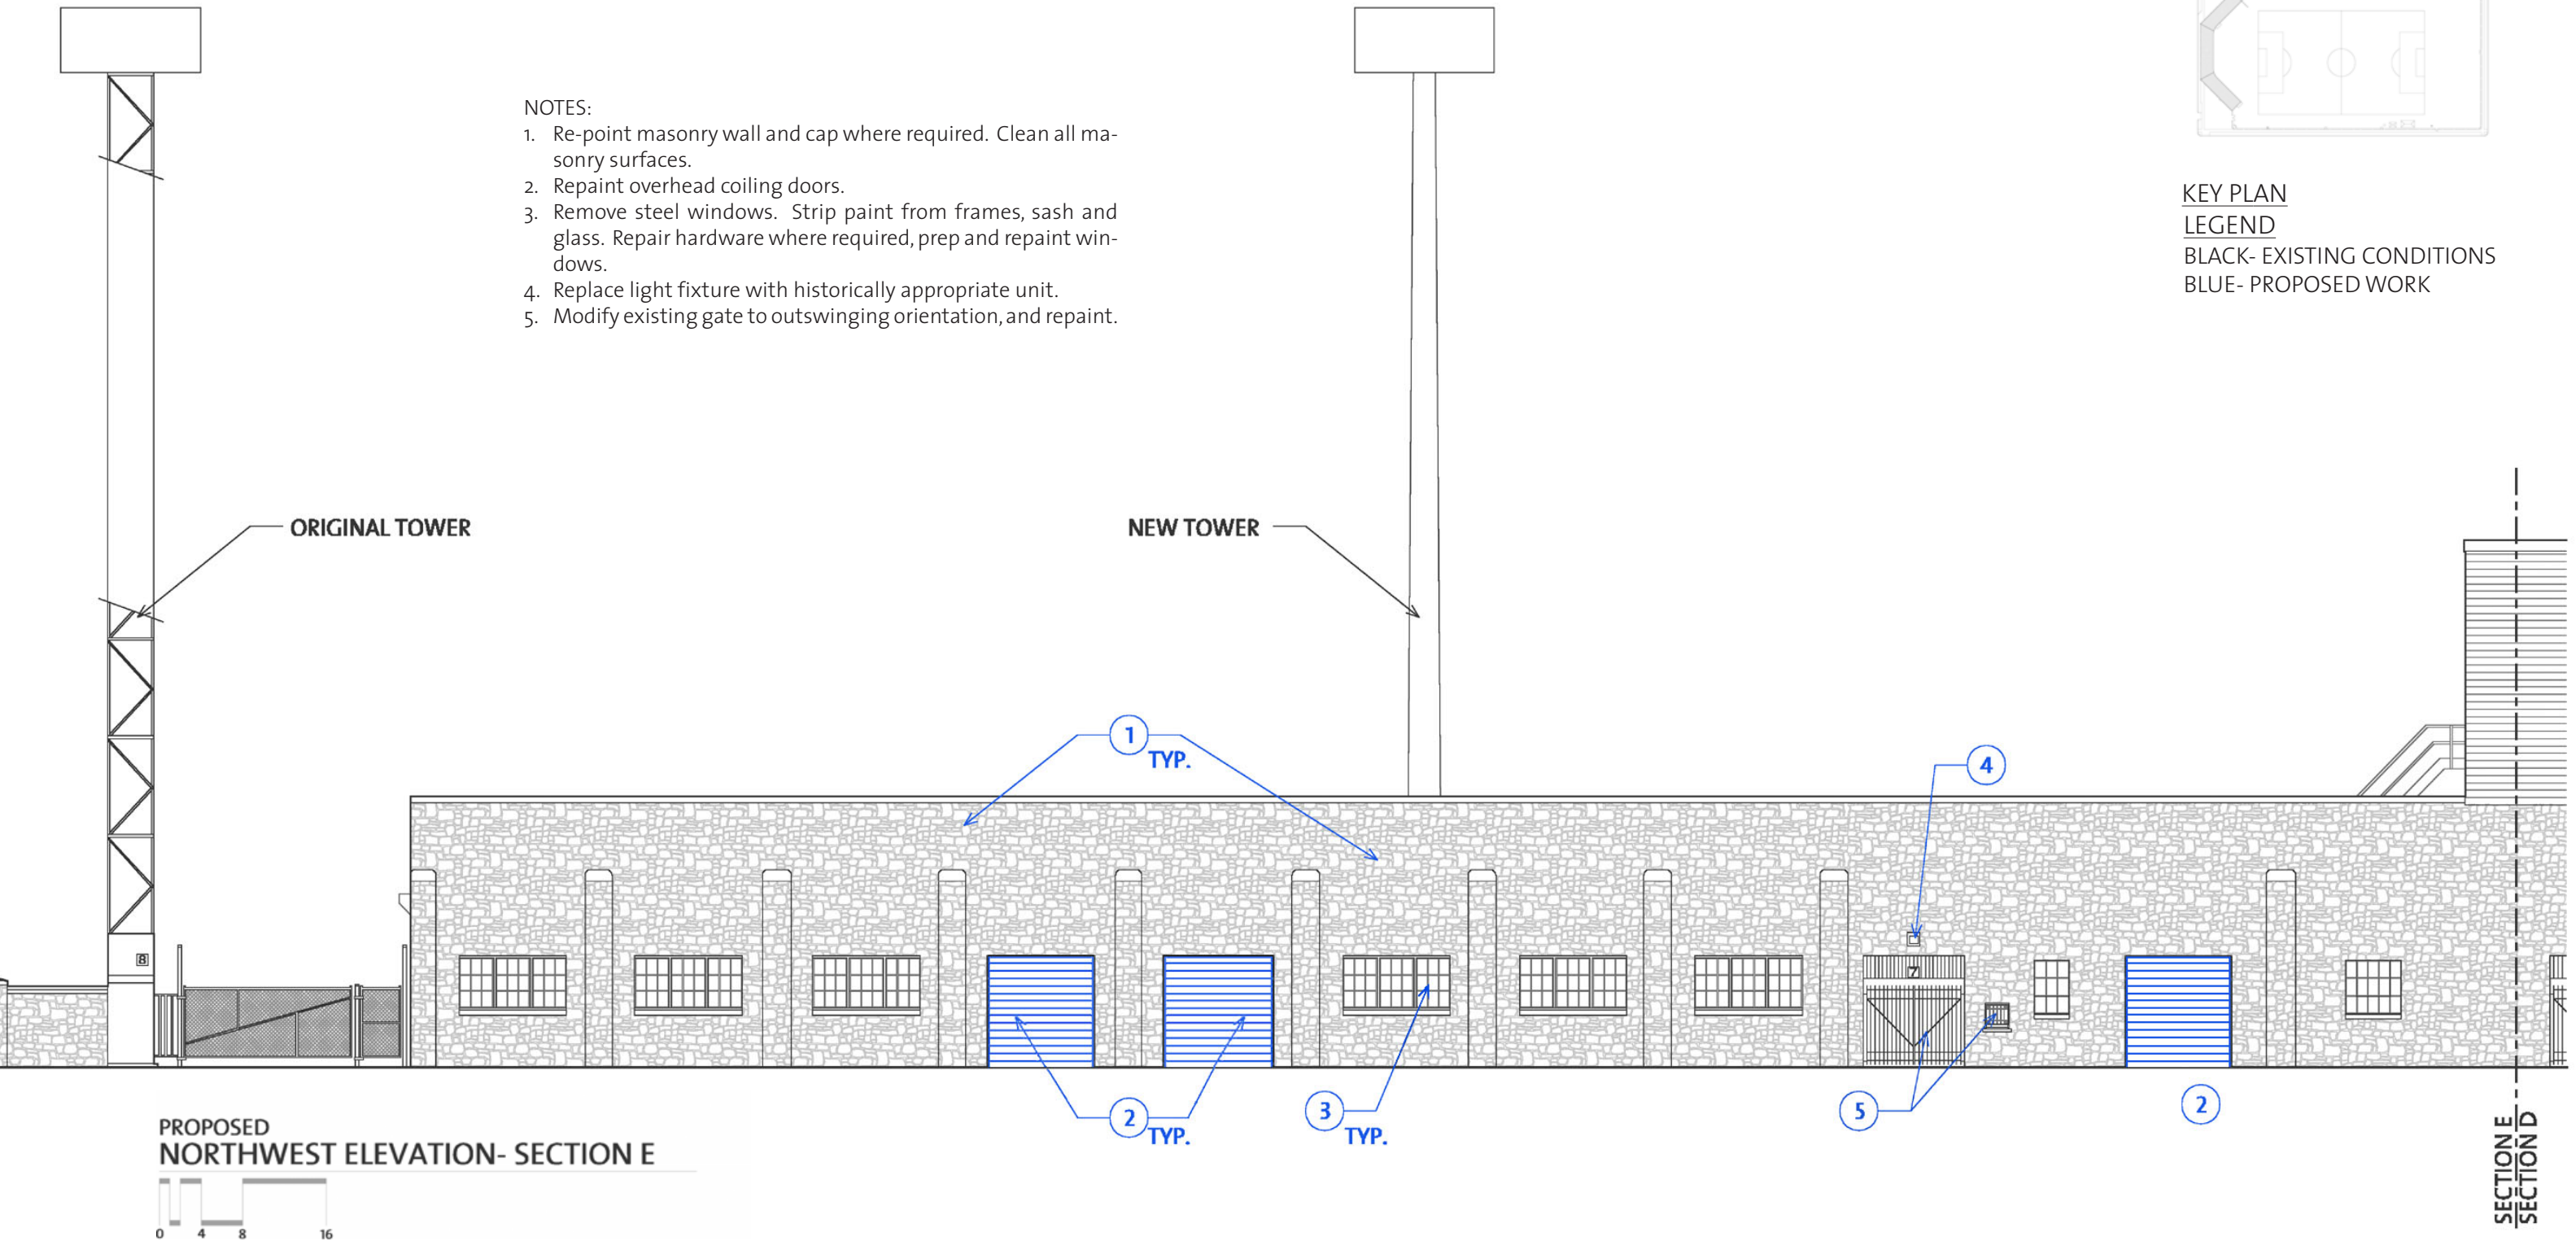
PROPOSED
NORTHWEST ELEVATION- SECTION E

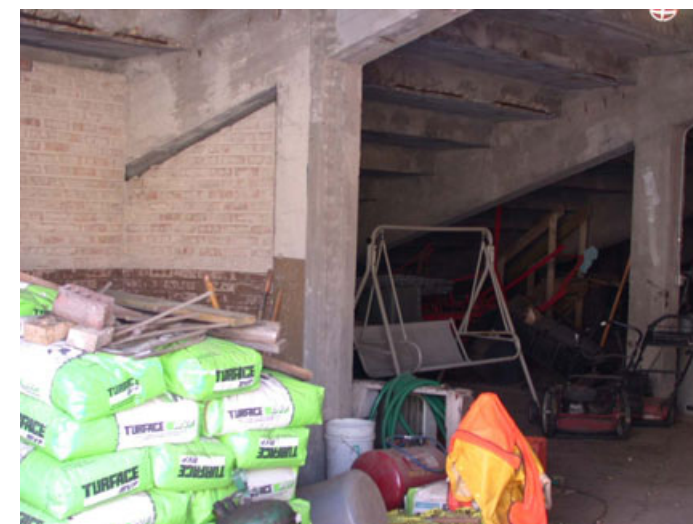
FIGURE 48: Interior of maintenance storage area showing damaged concrete slab. (2002)

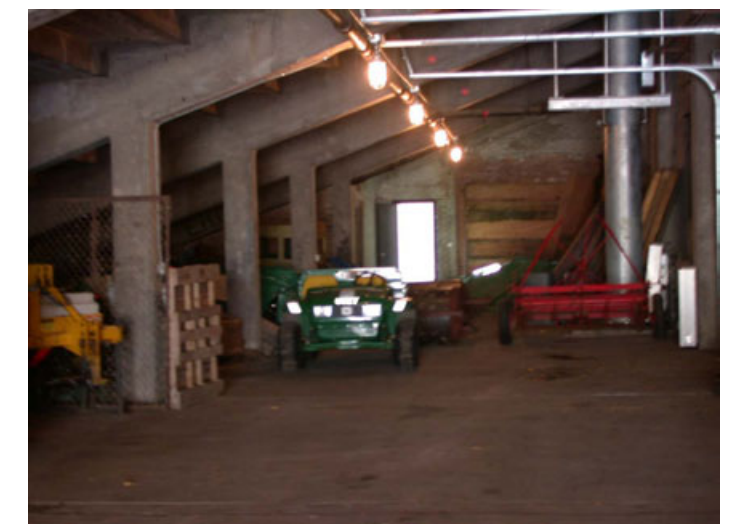
FIGURE 49: Interior of maintenance storage area looking southwest. (2002)

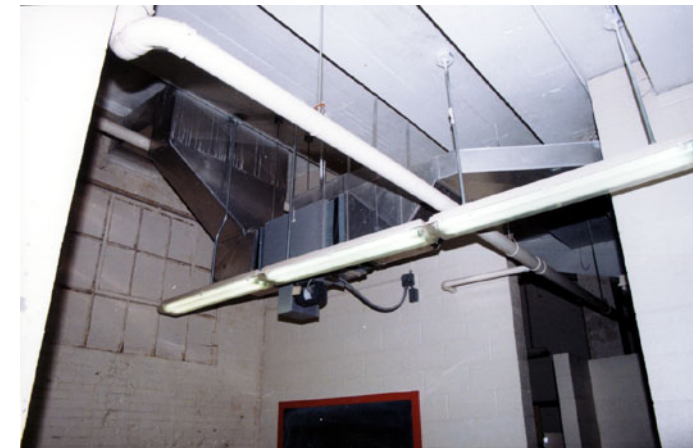
FIGURE 50: Locker room exhaust fan. (2002)

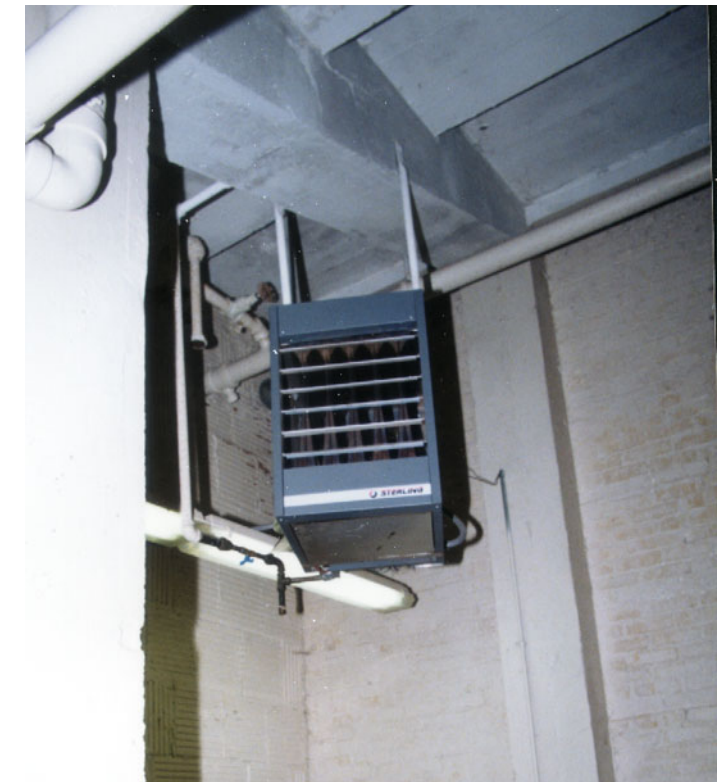
FIGURE 51: Locker room unit heater. (2002)

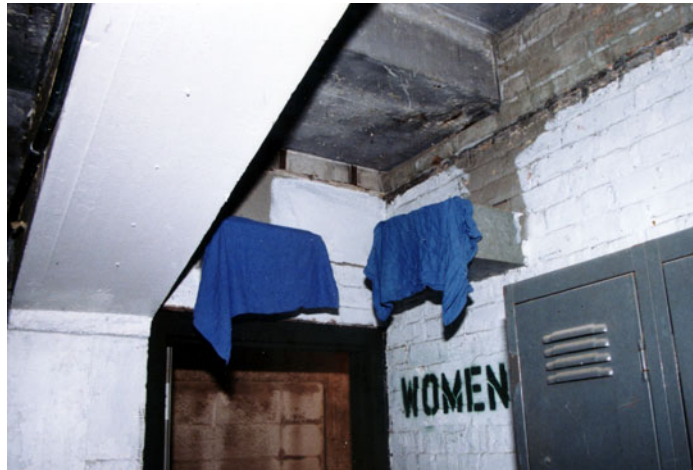
FIGURE 52: Partially dismantled ductwork in the Women's rest room. (2002)

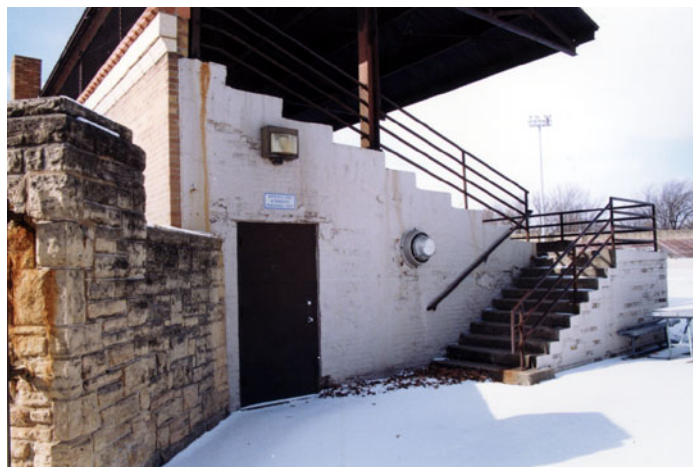
FIGURE 53: Exhaust vent located on the exterior of the building. (2002)

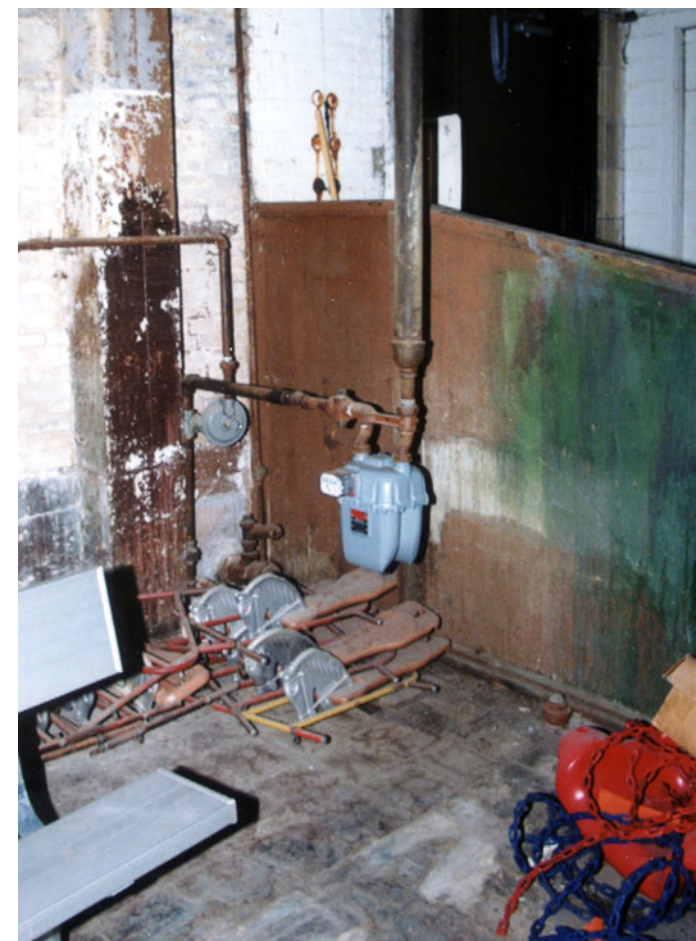
FIGURE 54: Gas meter and regulator inside building. (2002)

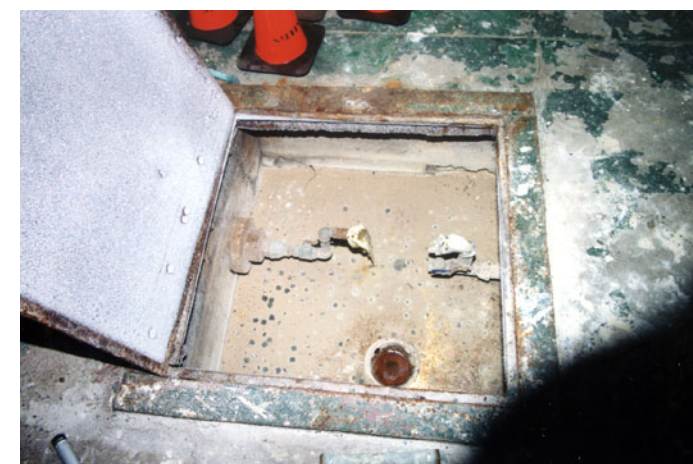
FIGURE 55: Former location of the water meter. (2002)

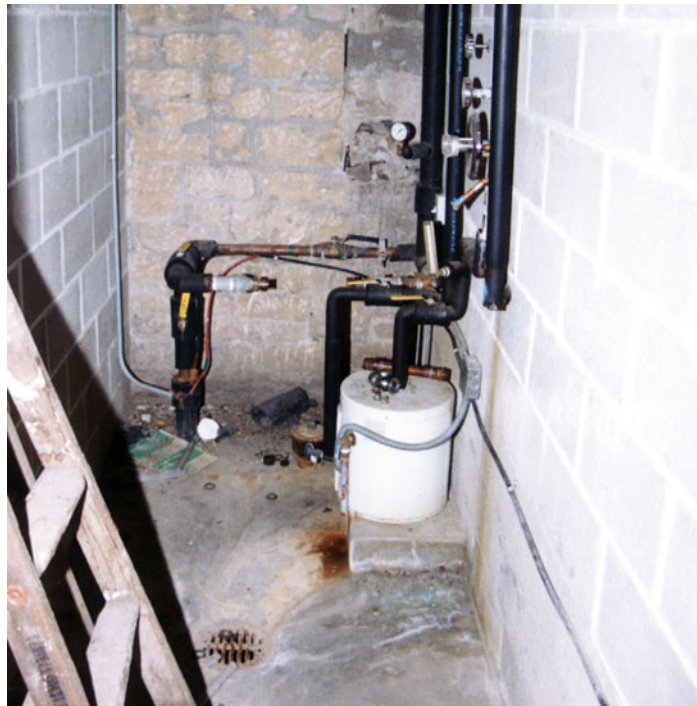
FIGURE 56: Newer copper piping tied into original steel pipes. (2002)

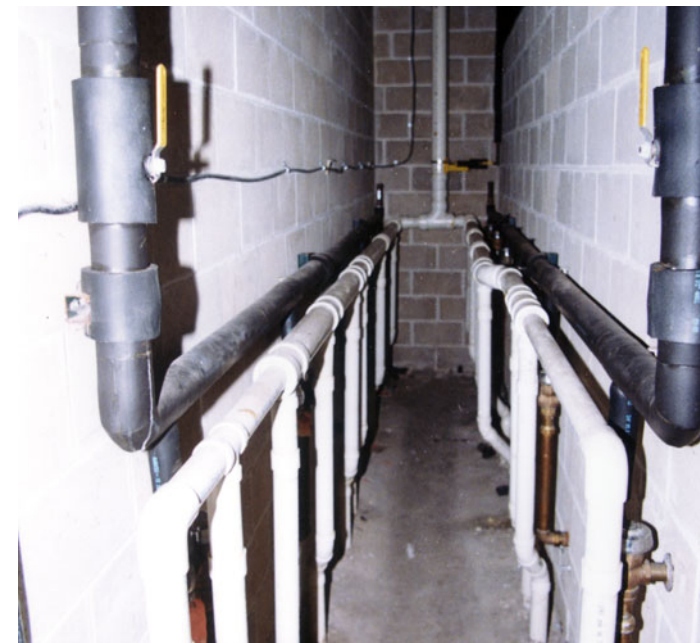
FIGURE 57: New PVC sanitary drainage piping. (2002)

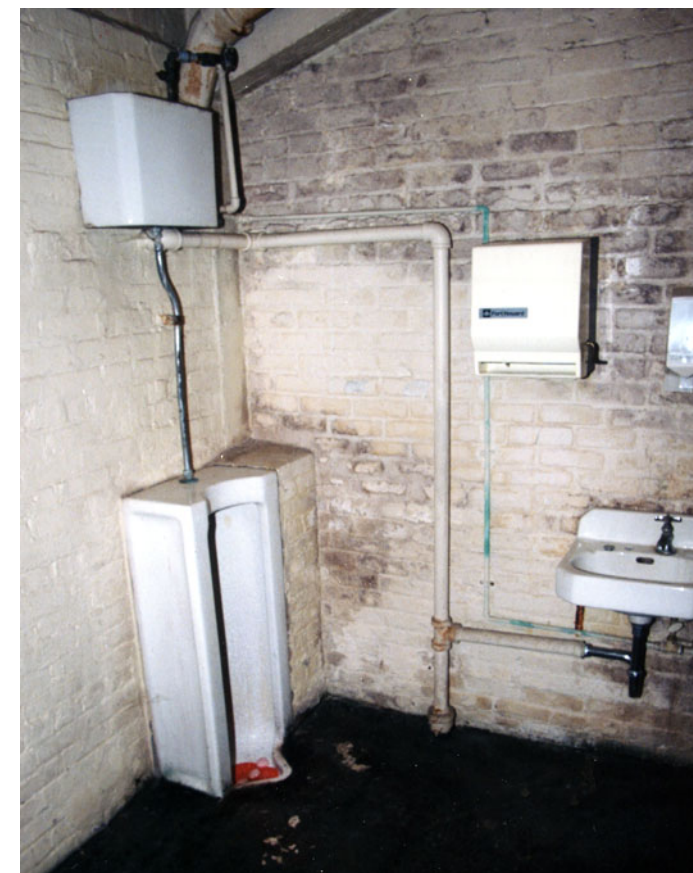
FIGURE 58: Toilet room with original cast iron and steel piping. (2002)

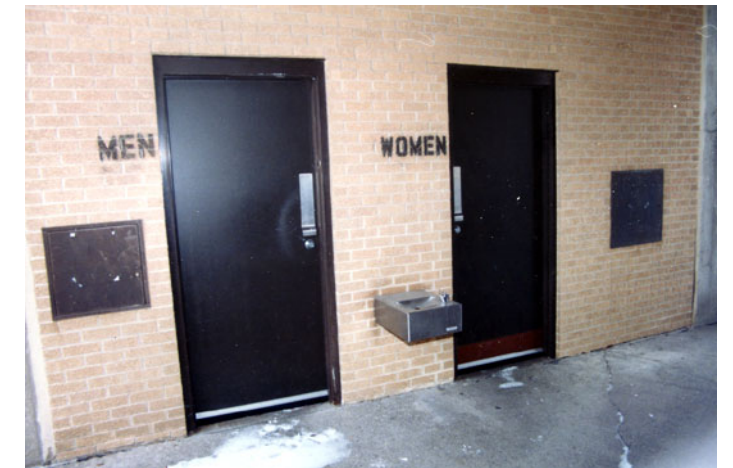
FIGURE 59: Vandal-resistant stainless steel fixture. (2002)

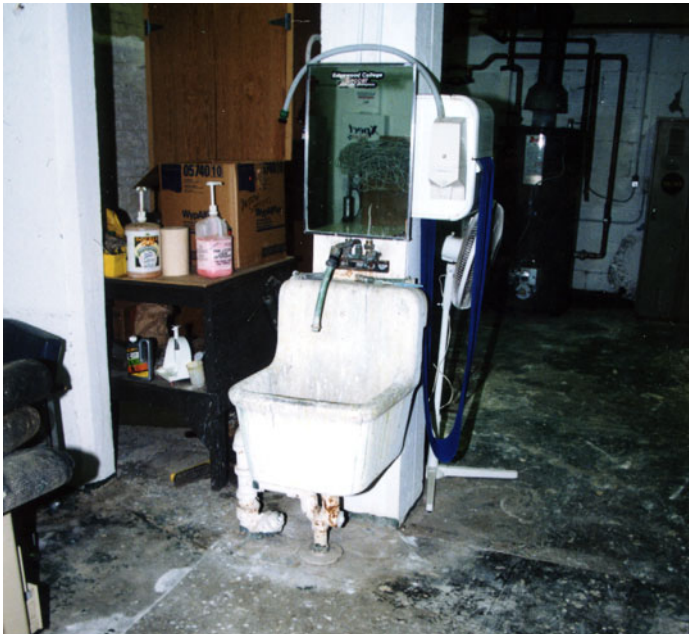
FIGURE 60: Service sink in Maintenance Room. (2002)
