BREESE STEVENS FIELD

HISTORIC STRUCTURE REPORT

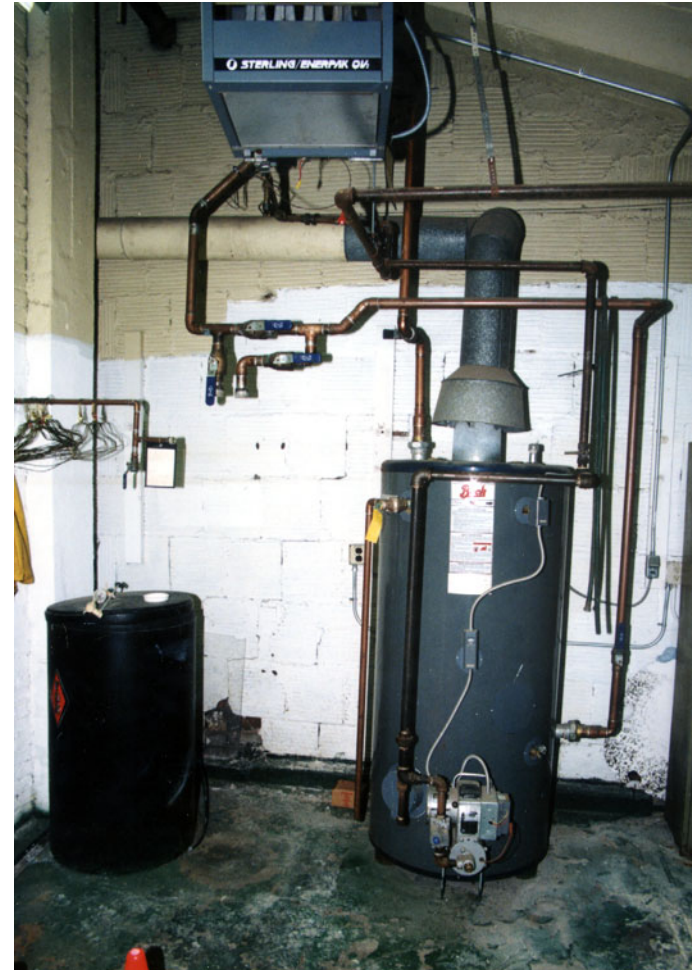
FIGURE 61: Gas fired water heater in Maintenance Room. (2002)

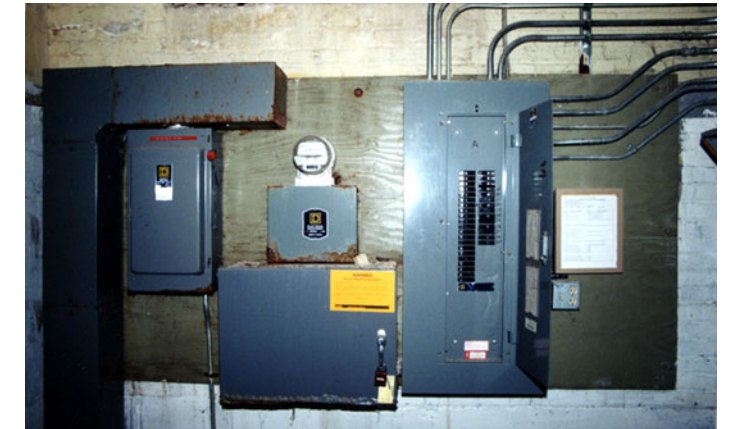
FIGURE 62: Electrical service 'A' (2002)

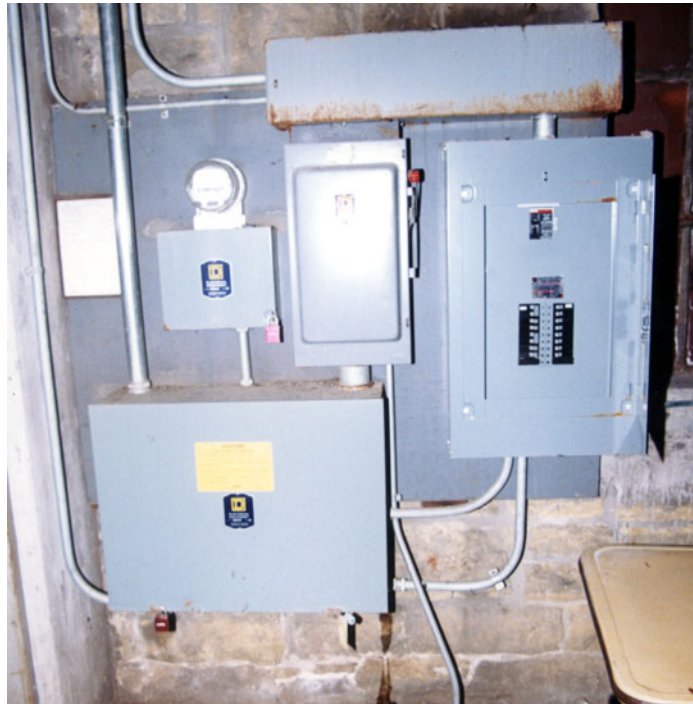
FIGURE 63: Electrical service 'C'. (2002)

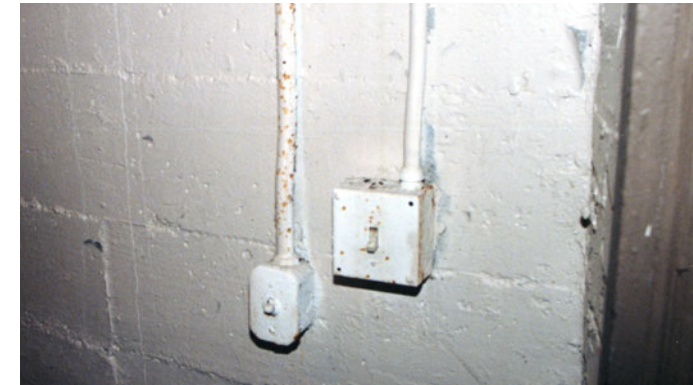
FIGURE 66: Typical surface munter electrical conduit. (2002)

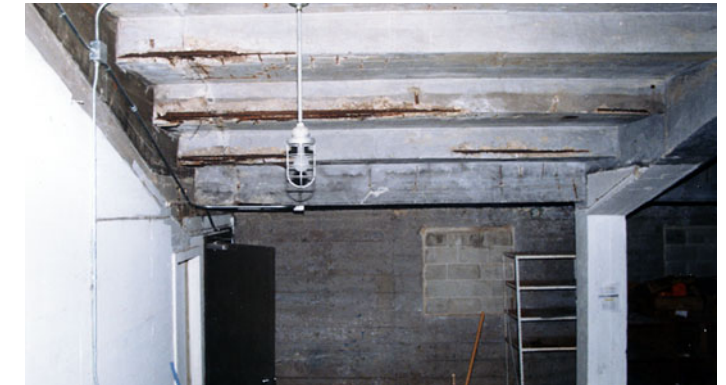
FIGURE 67: Typical interior incandescent fixture. (2002)

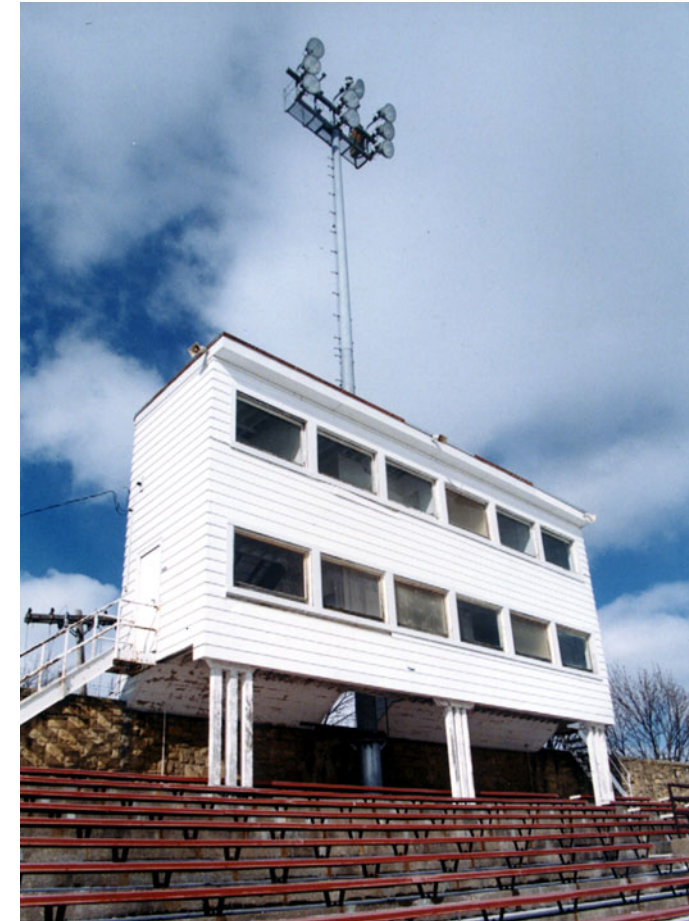
FIGURE 71: Press Box. (2002)

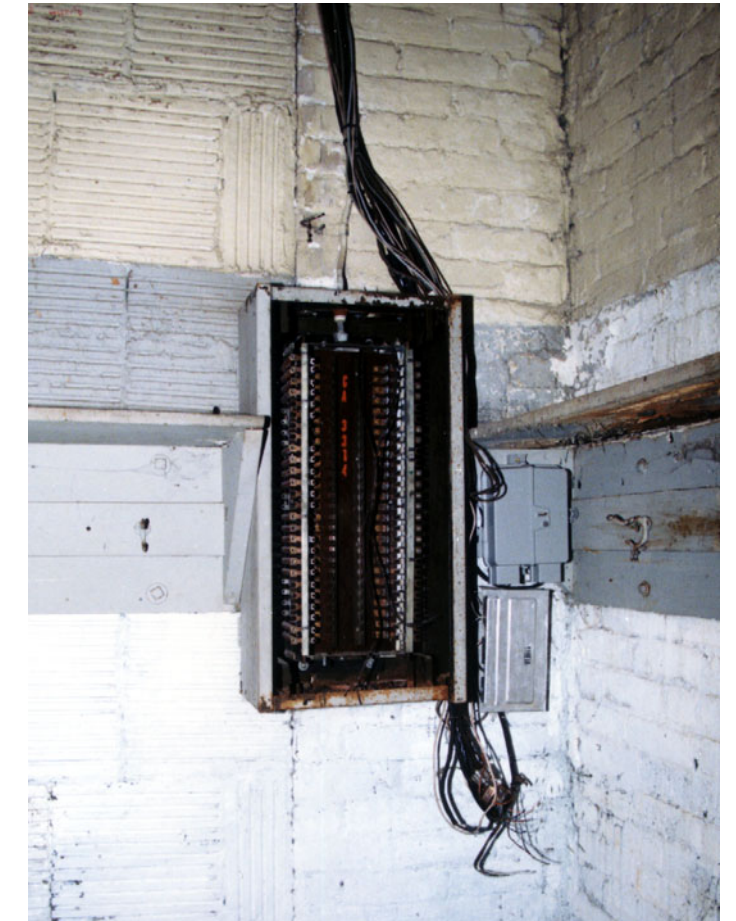
FIGURE 72: Unused and deteriorated electrical equipment to be removed. (2002)
